Reserve Fund Study

ID Inglewood - Condominium Corporation No. 1612056

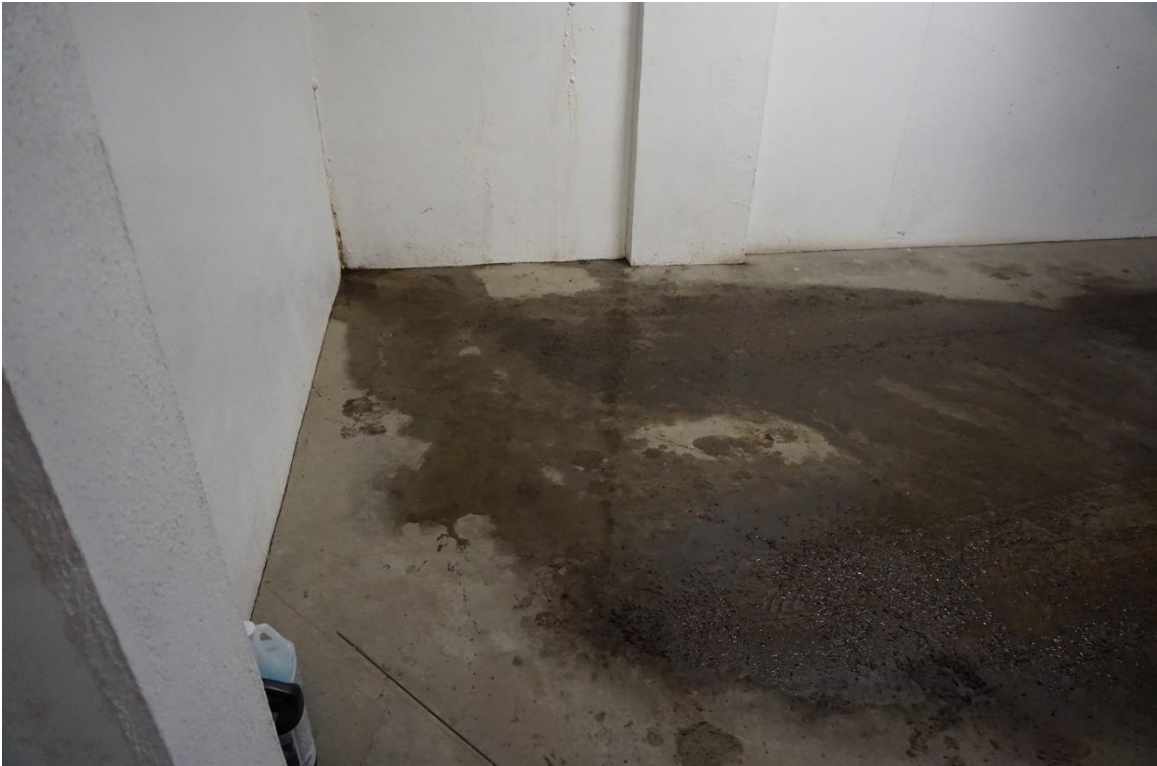
Figure 2 - Leaking from wall and onto slab.

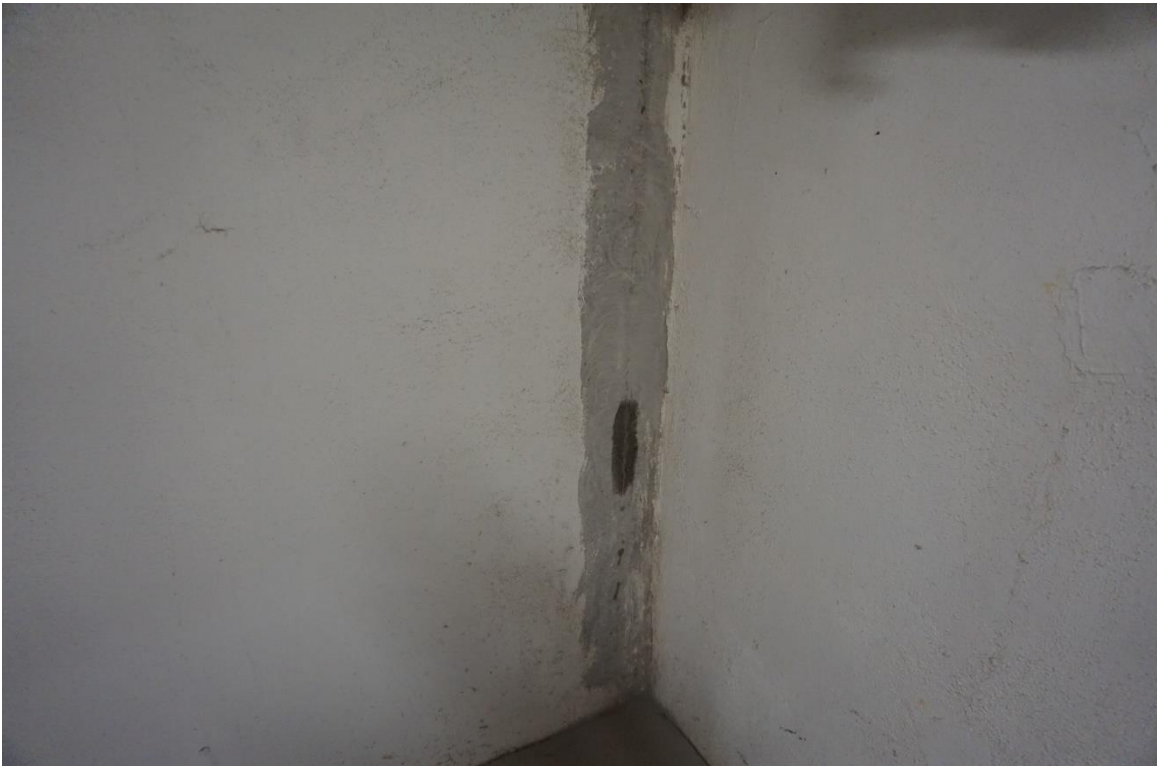
Figure 3 - Leak patched but still leaking.

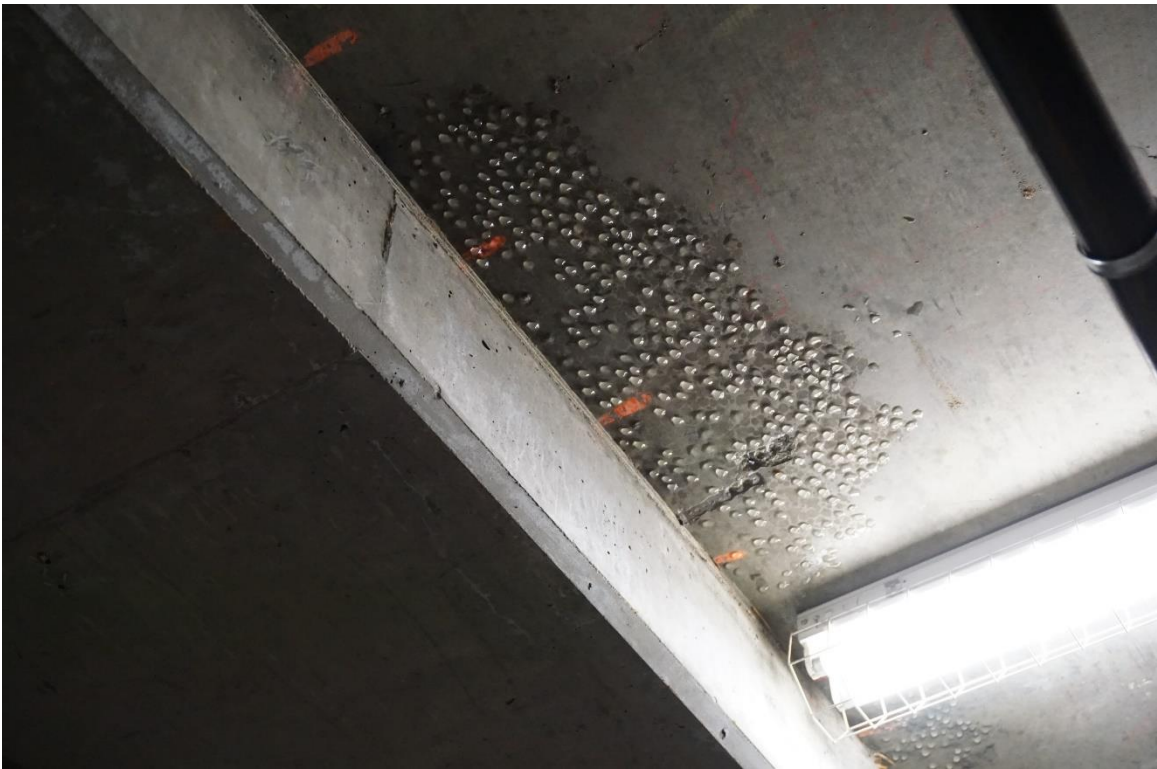
Figure 4 - Condensation on garage ceiling.

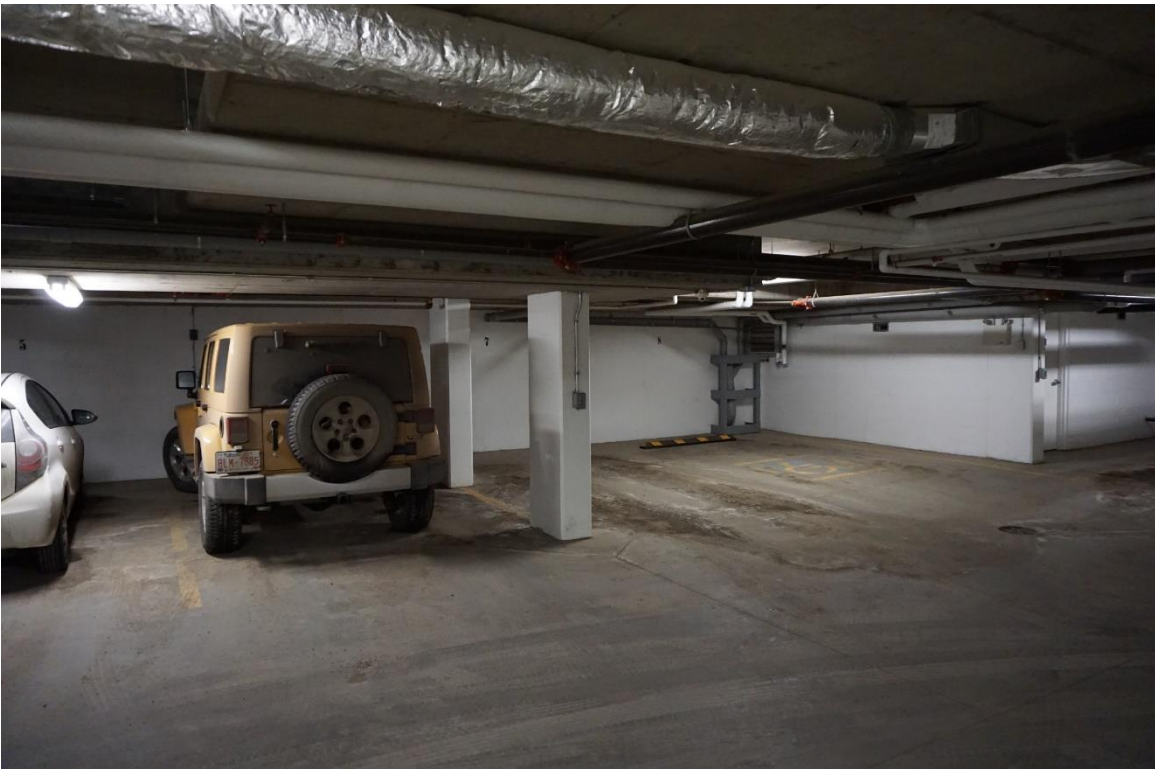
Figure 6 - Note the white salt staining on the slab.

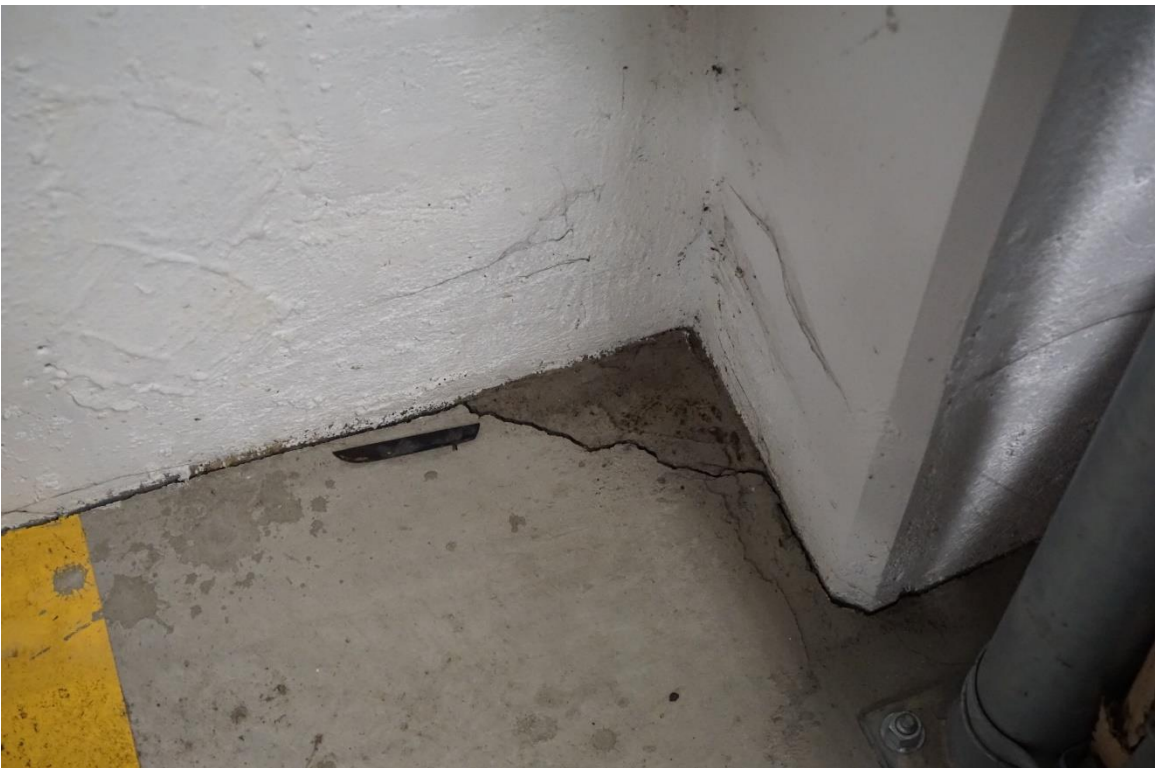
Figure 7 - Minor settlement cracking.

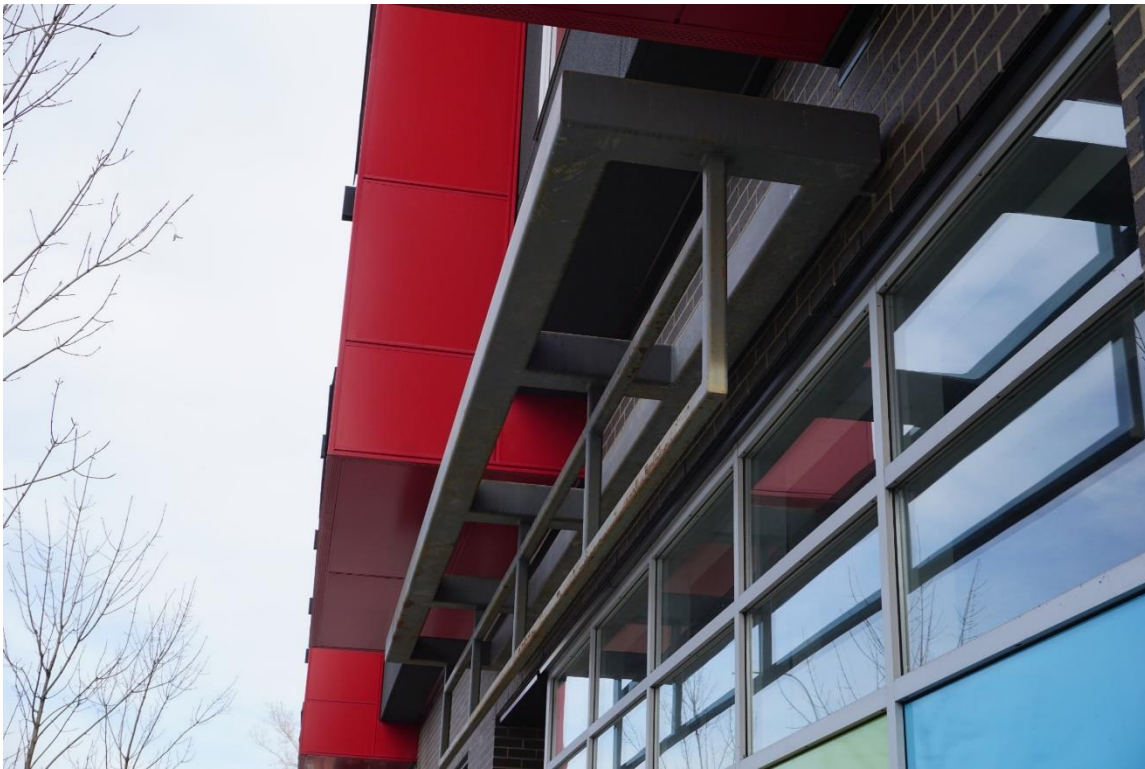
Figure 8 - Example steel signage canopy.

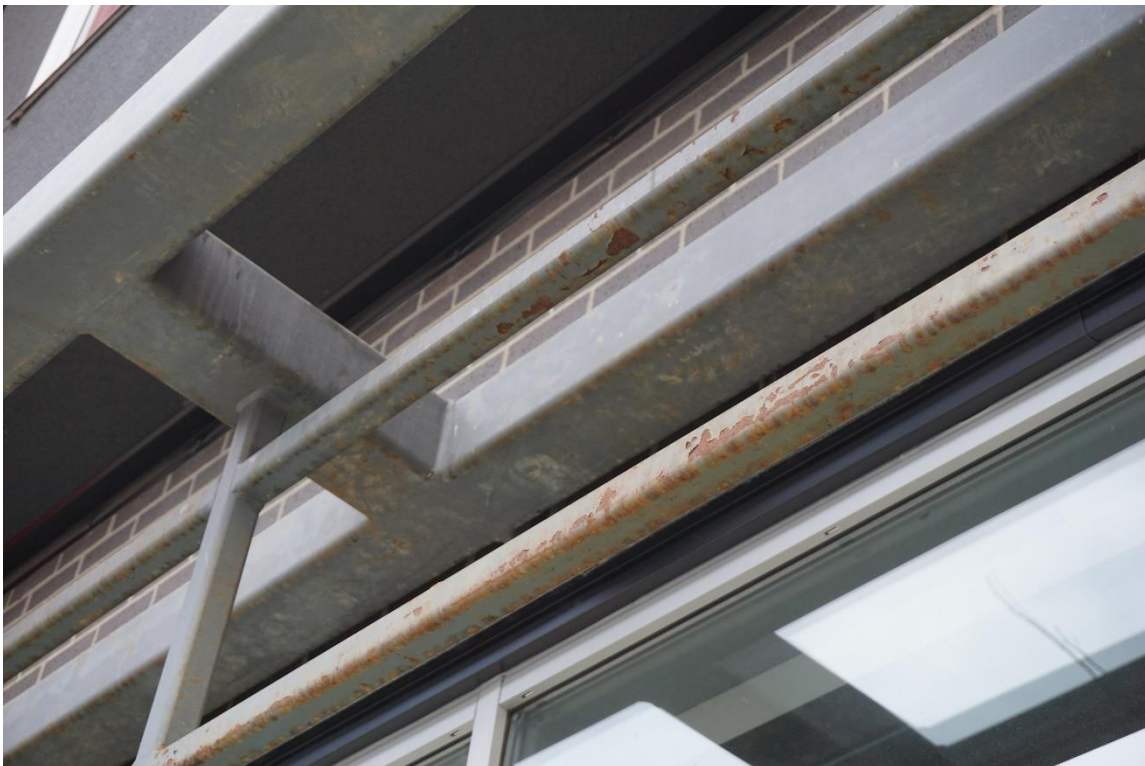
Figure 9 - Condition during our first visit. Top coating over this steel will not yield good results. Proper preparation must be done.

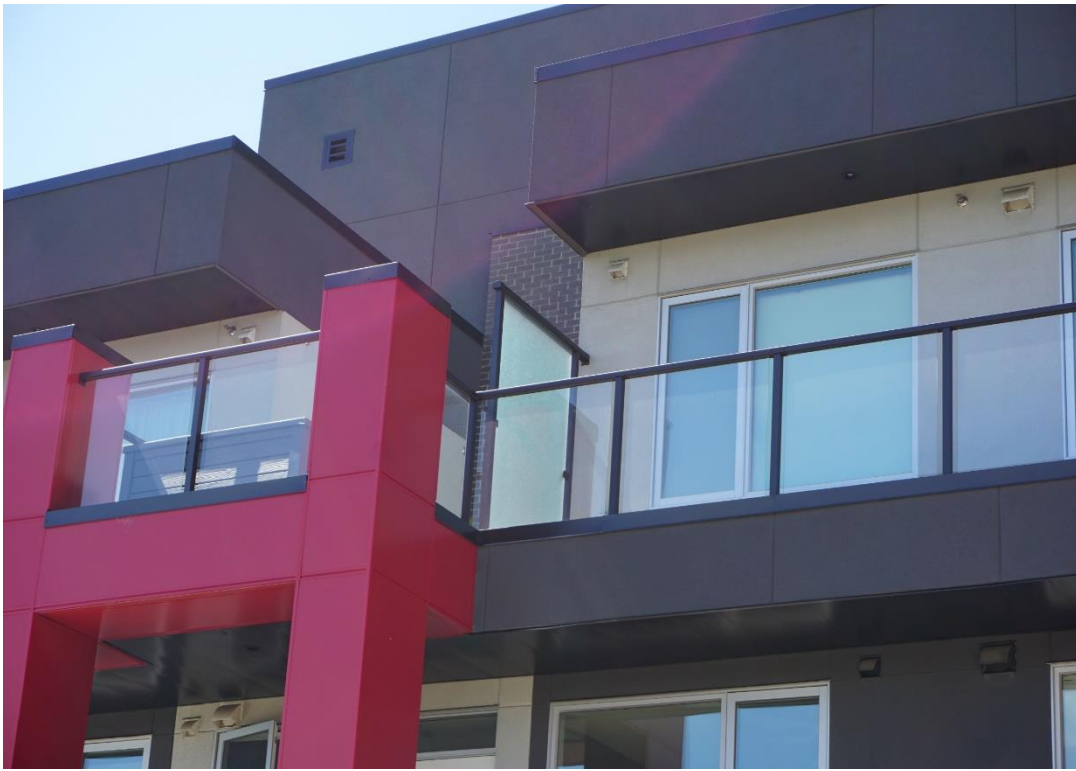
Figure 10 - Glass balcony railings and privacy glass between units.

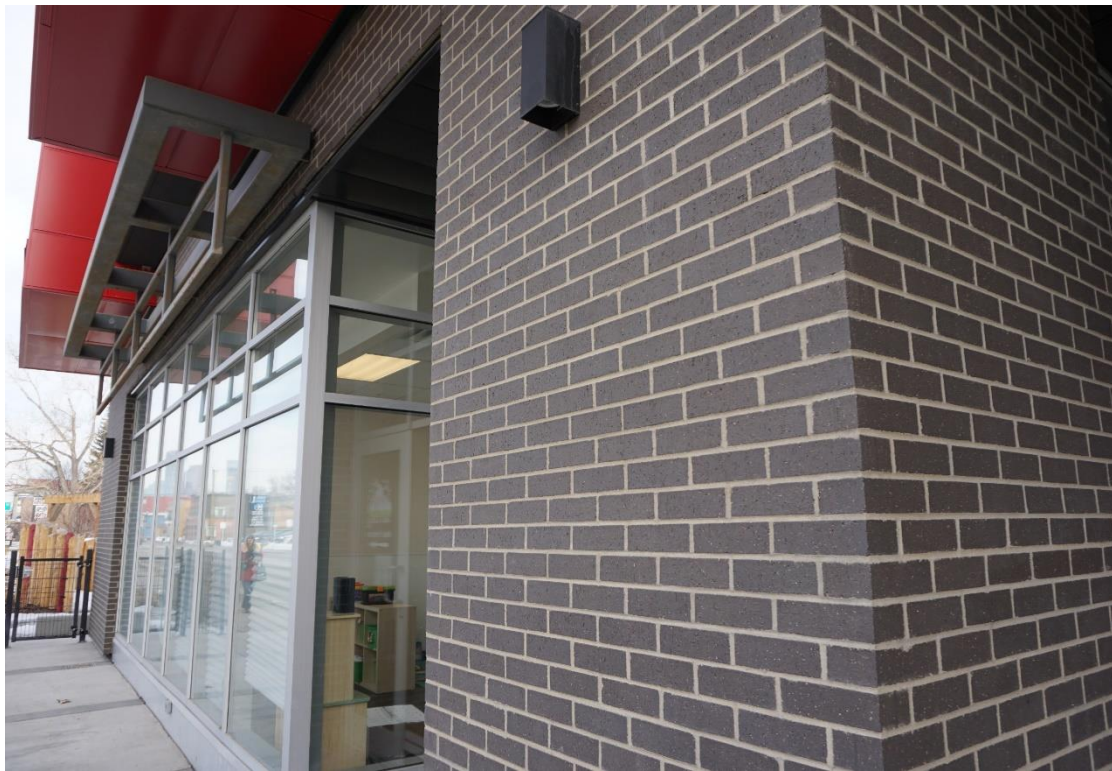
Figure 11 - Example of brick exterior walls.

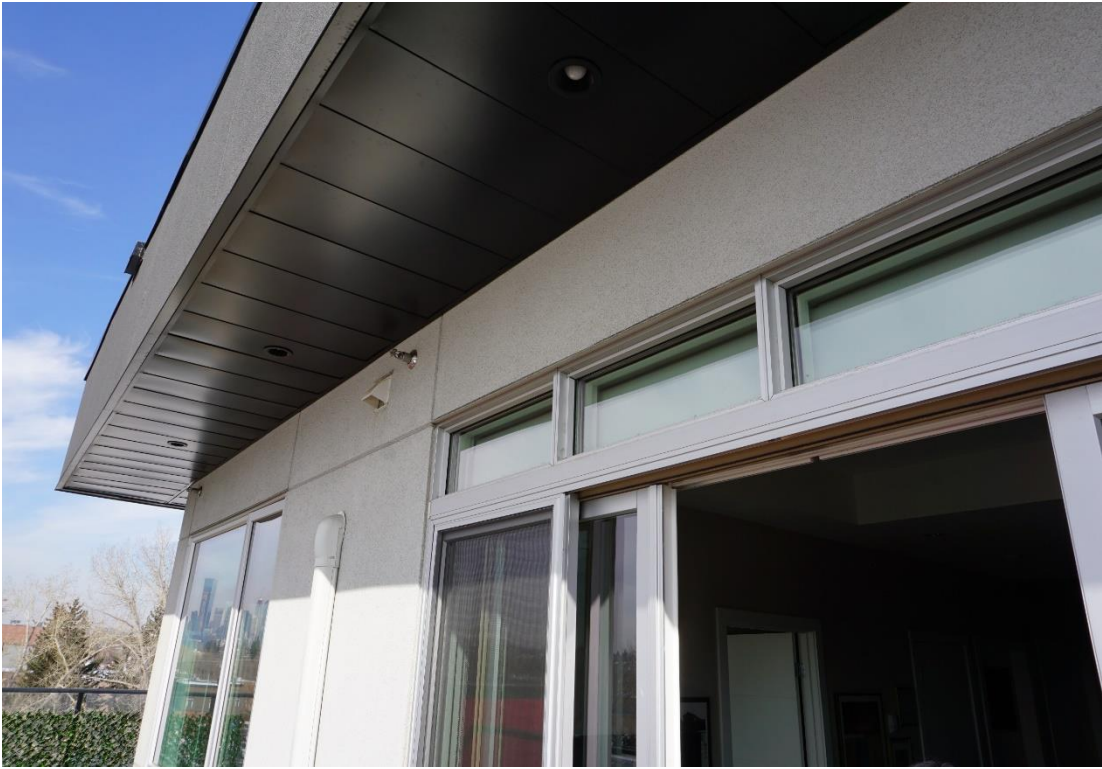
Figure 14 - Sliding glass balcony door.

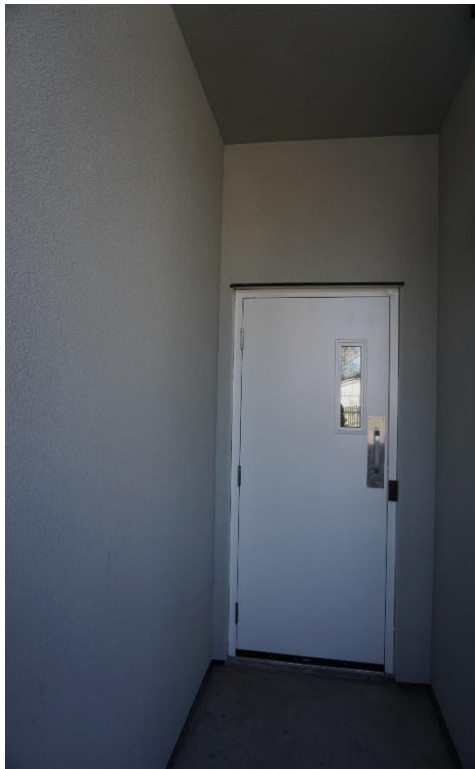
Figure 16 - Example of an exterior, painted, hollow core metal door with vision lite.

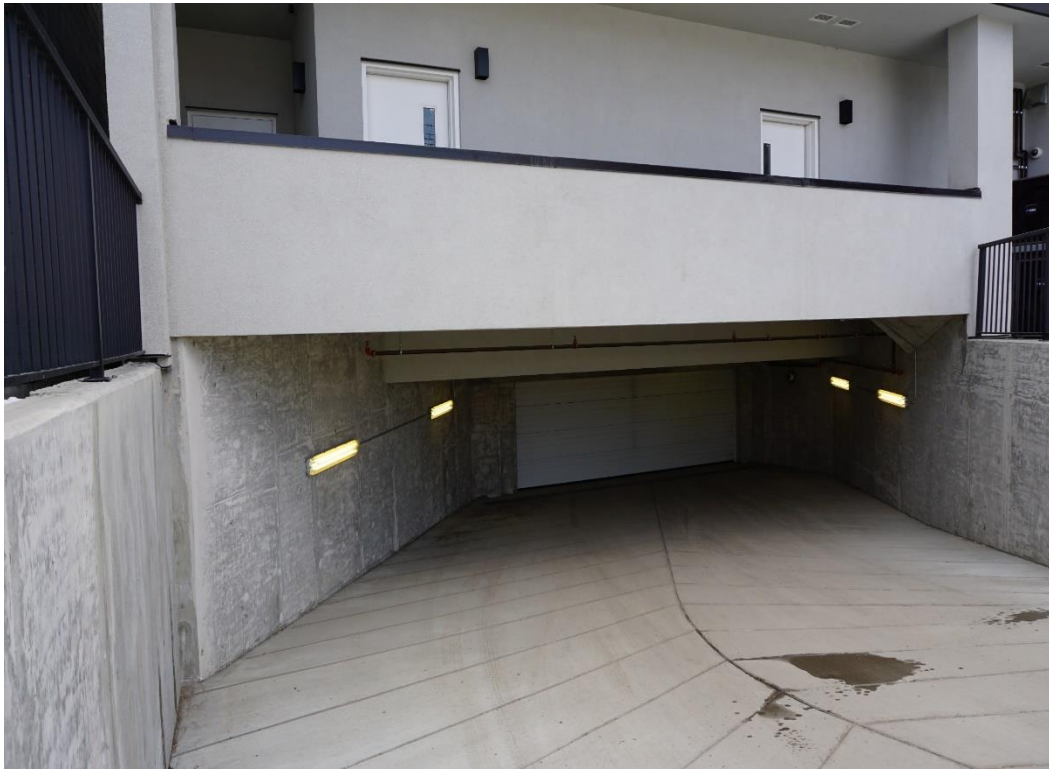
Figure 18 - Overhead door to the parkade.

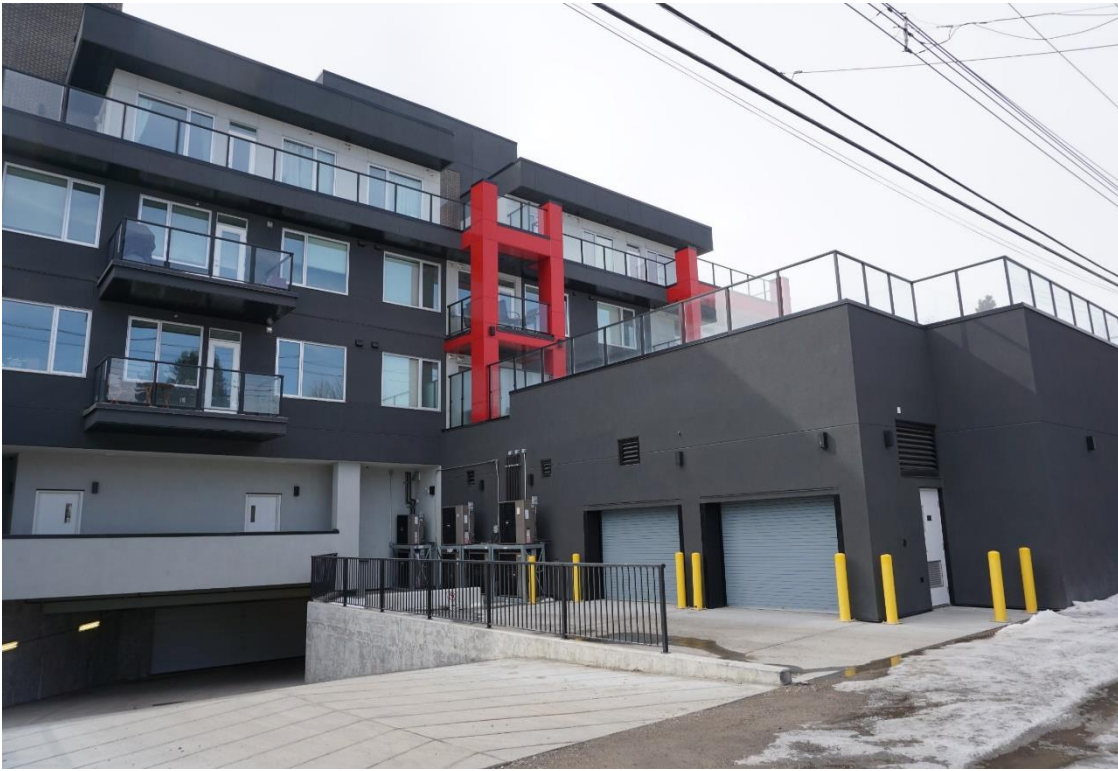
Figure 20 - Rolling service doors to the garbage room.

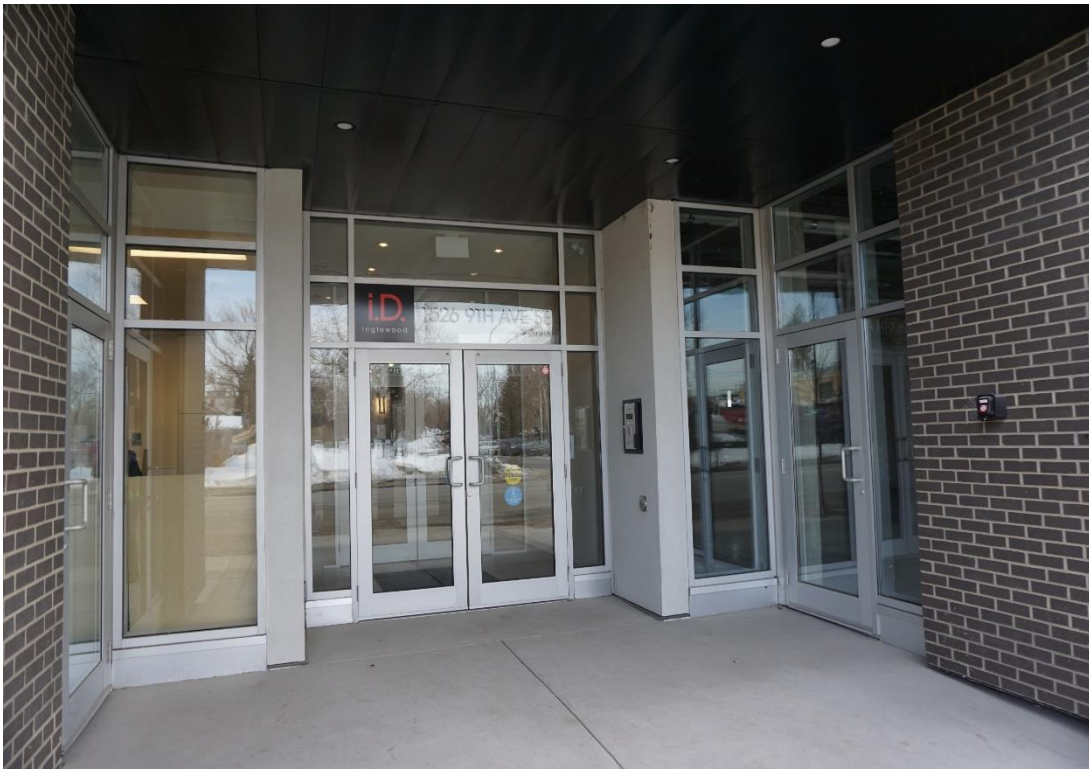
Figure 22 - Double and single storefront doors.

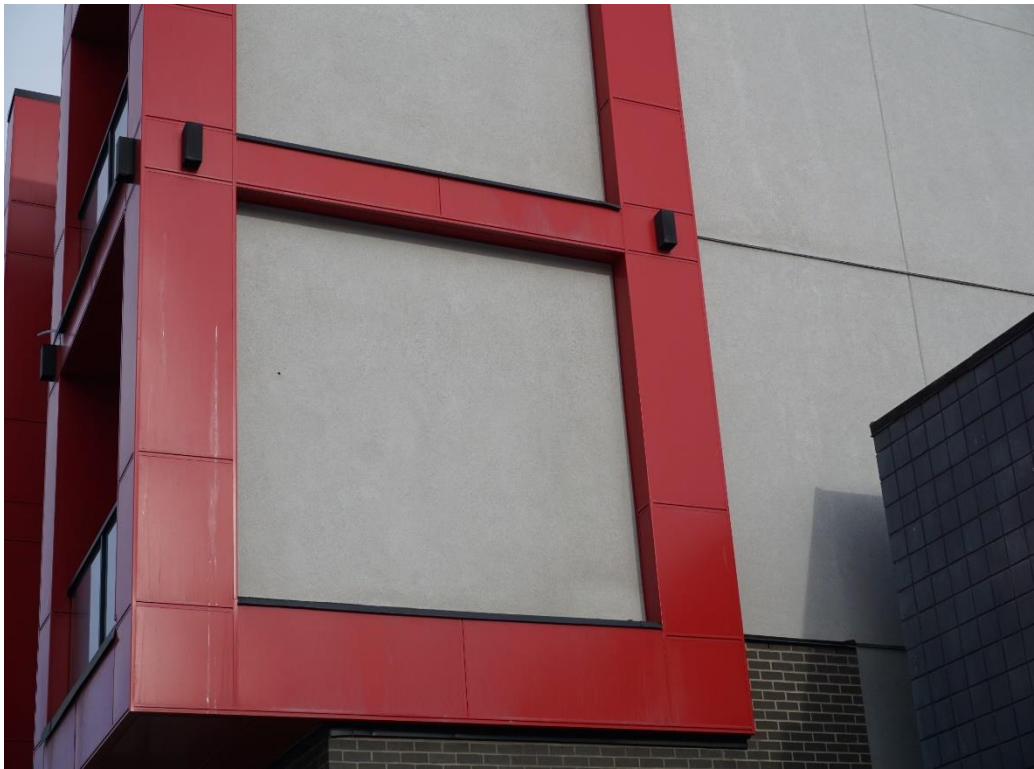
Figure 23 - EFIS on the east elevation.

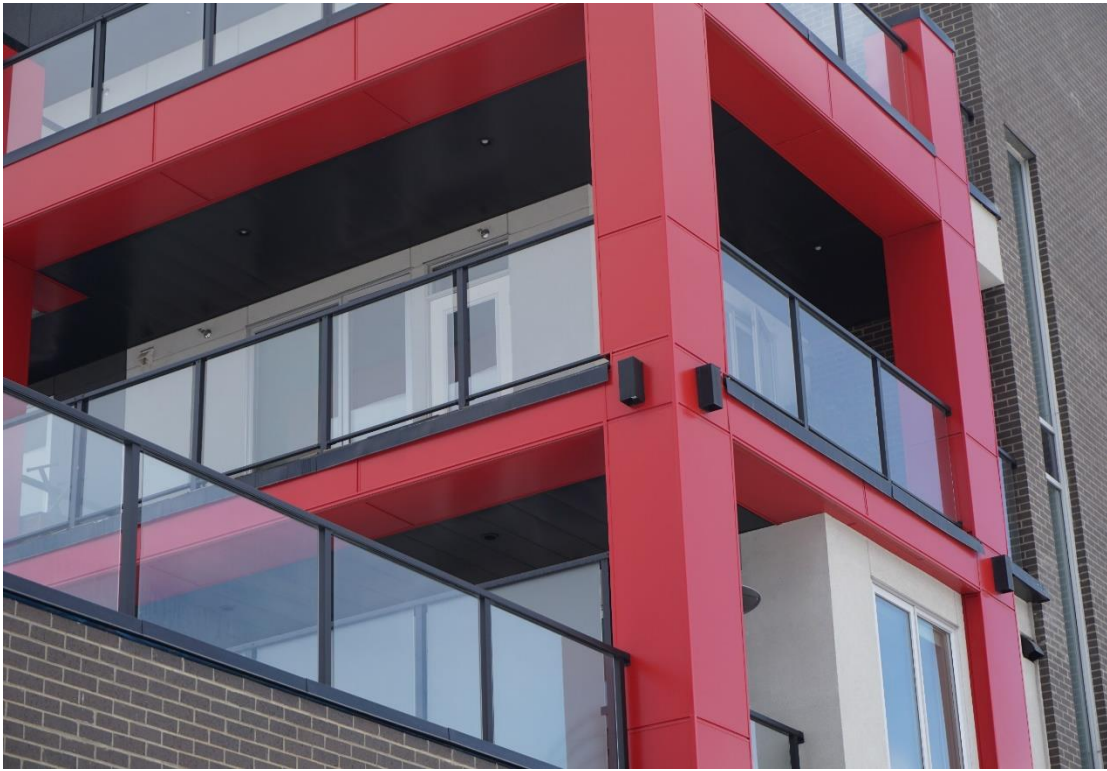
Figure 25 - Factory-finished metal panels.

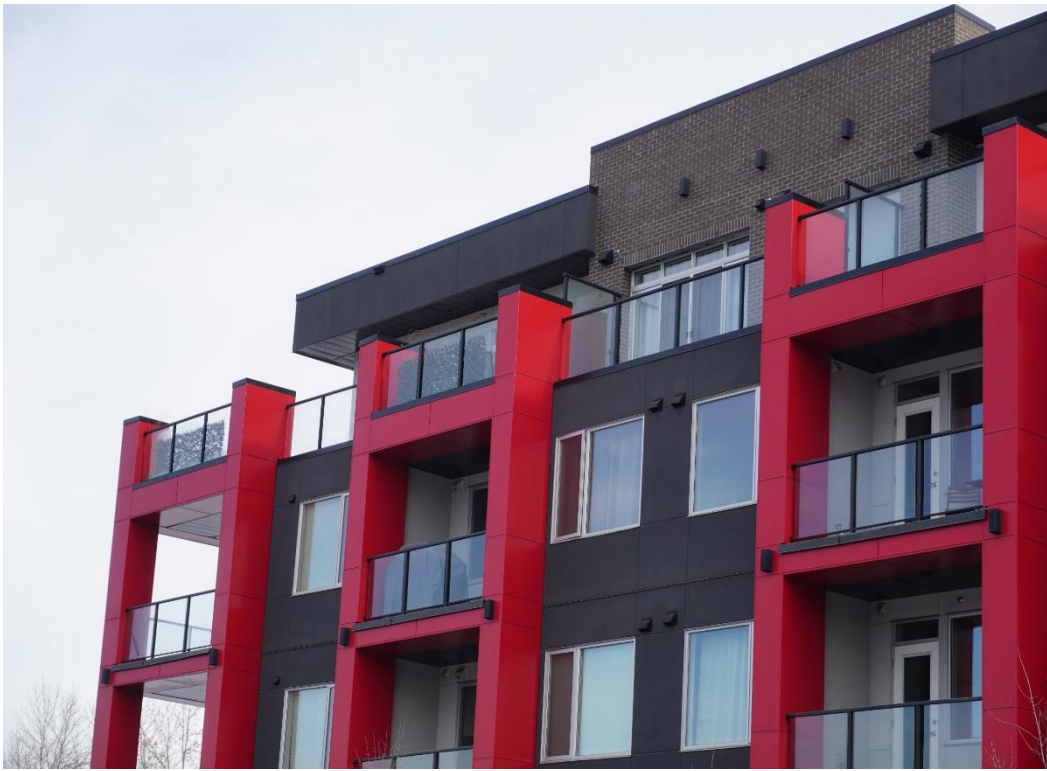
Figure 26 - Example of a combination fixed & casement window.

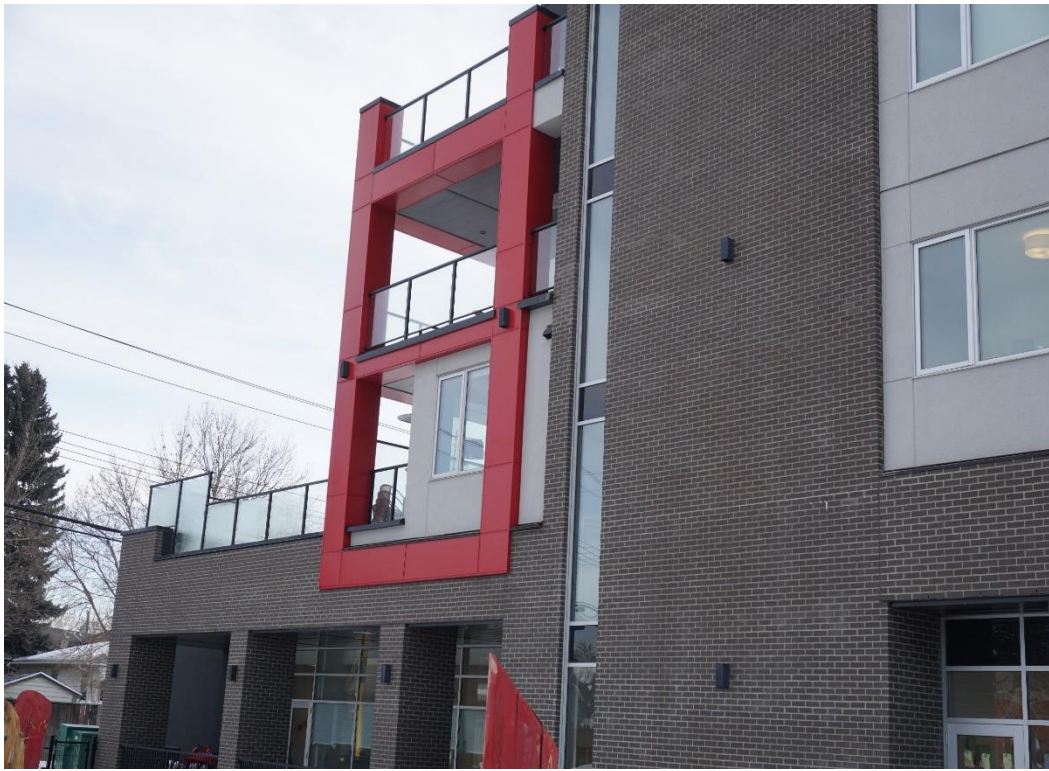
Figure 27 - Curtain wall window system in the west stairwell.

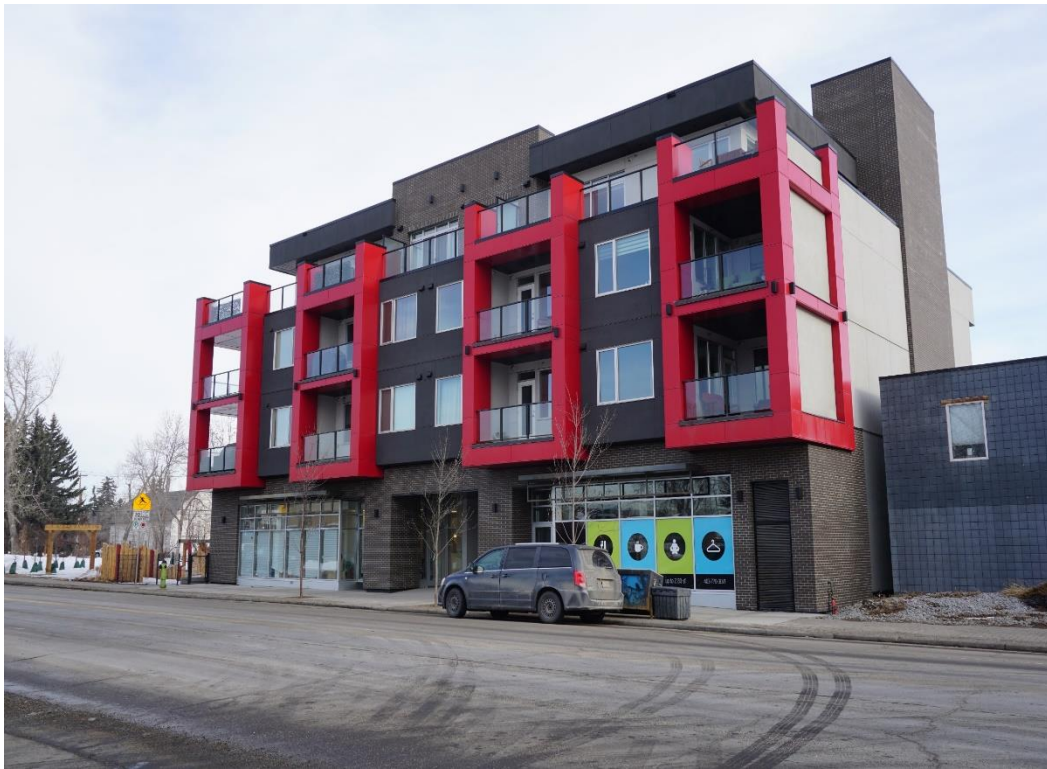
Figure 28 - Storefront window system on the main floor.

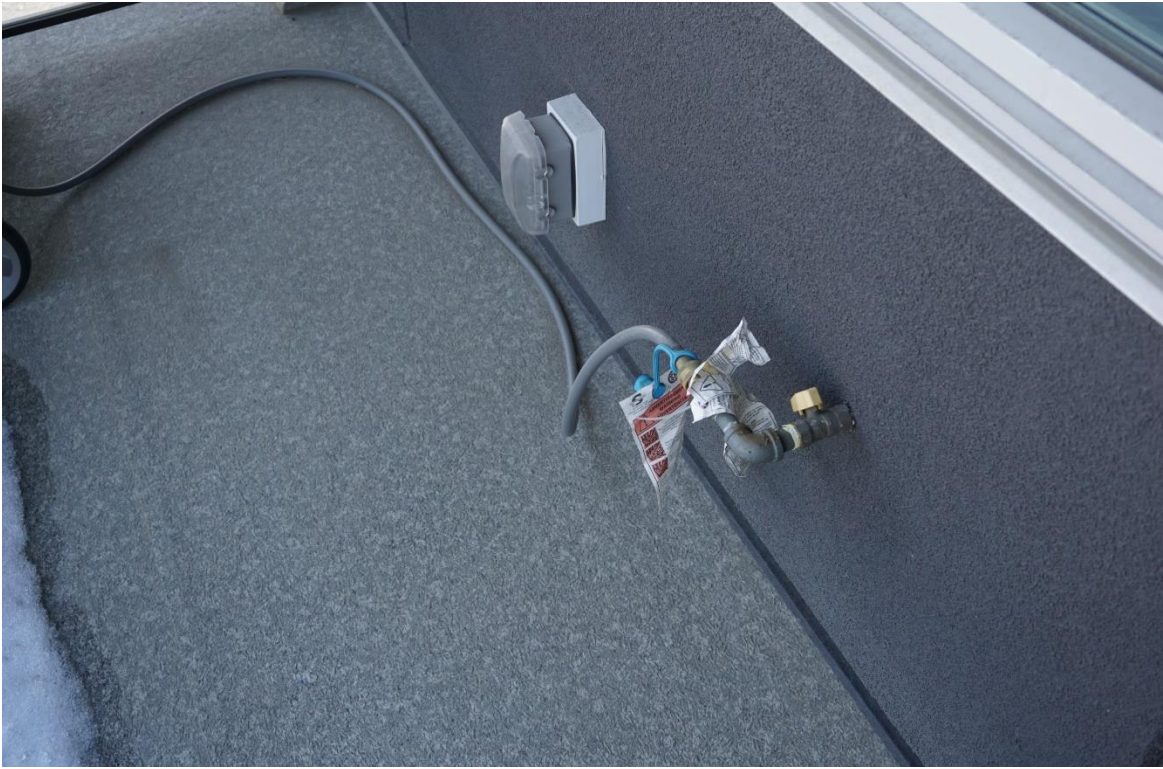
Figure 29 - Typical balcony vinyl water proofing membrane.

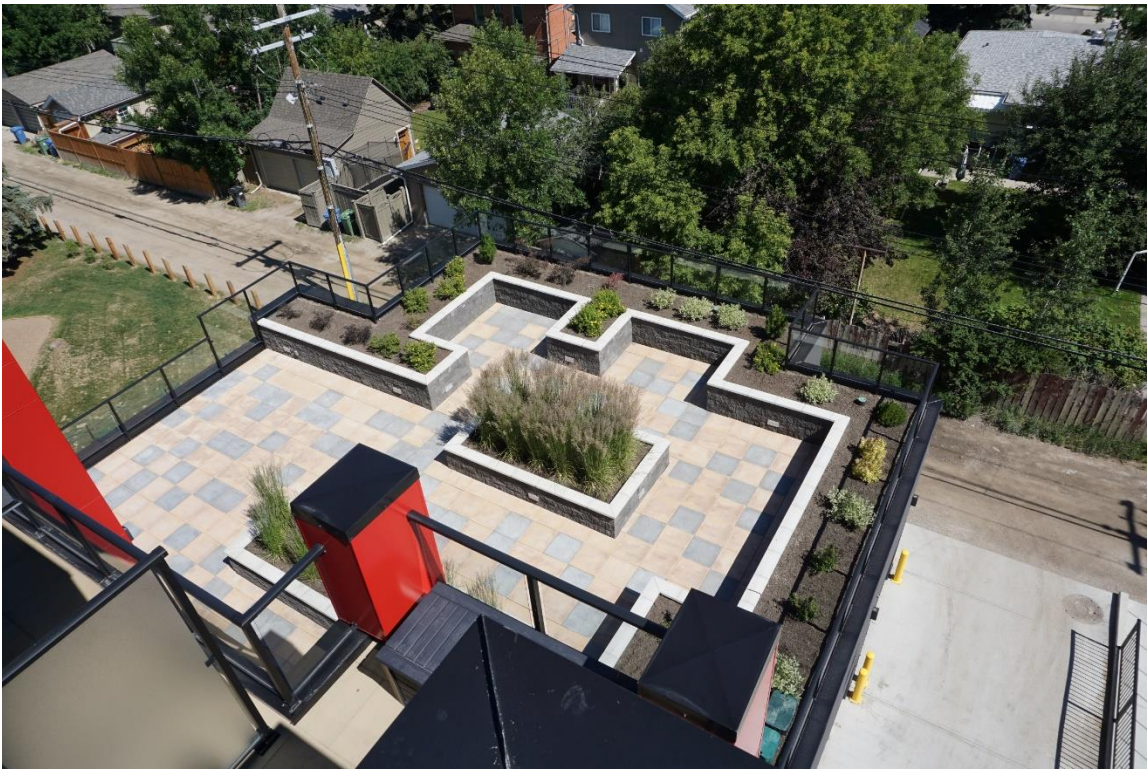
Figure 30 - View of the 2nd floor terrace.

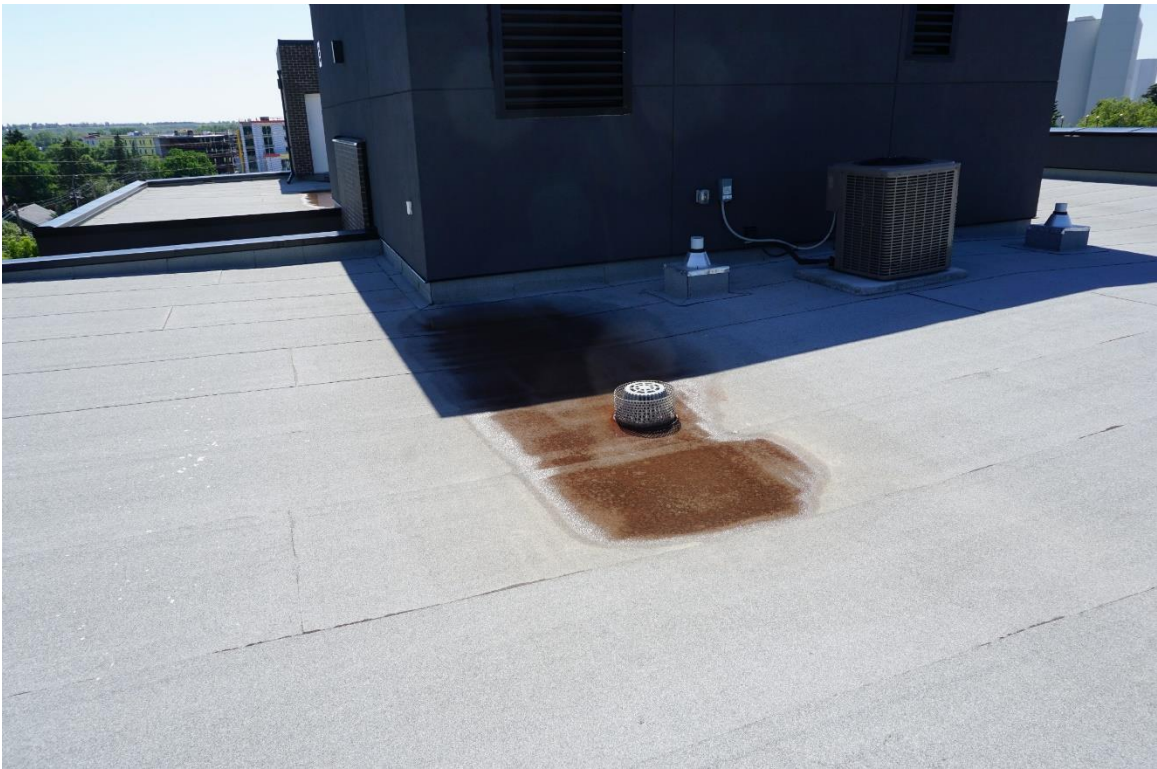
Figure 32 - Roof over 4th floor. Standing water present approaching the 48 hour mark.

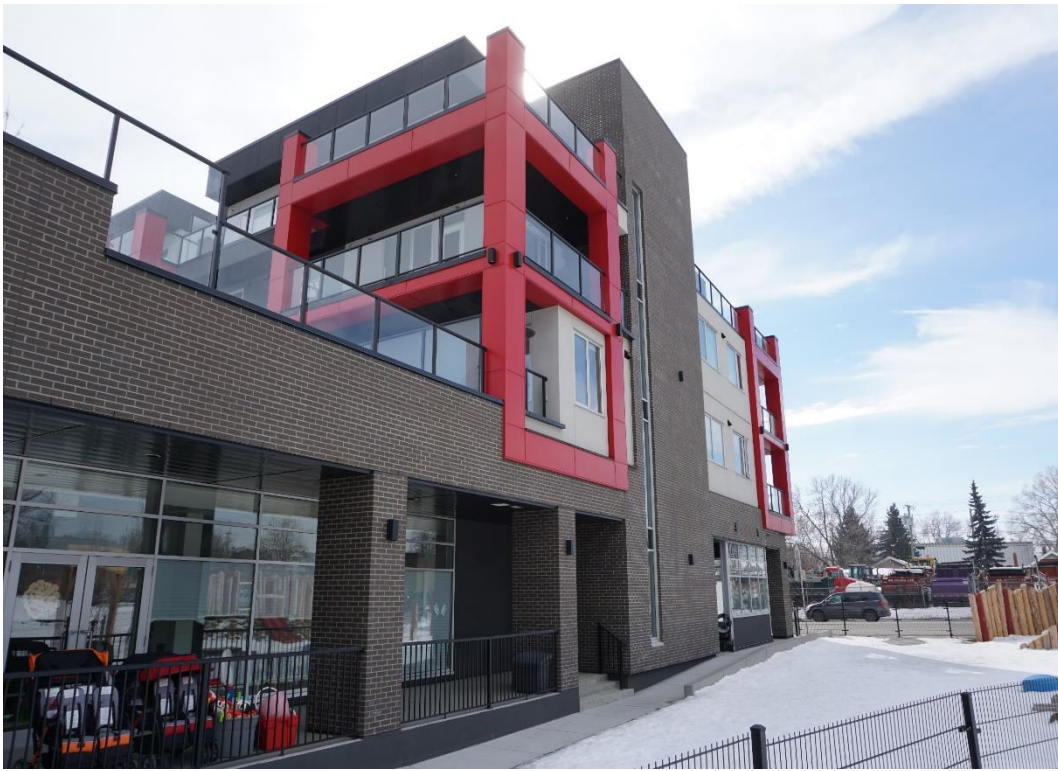
Figure 33 - Wall mounted LED down and up/down light fixtures.

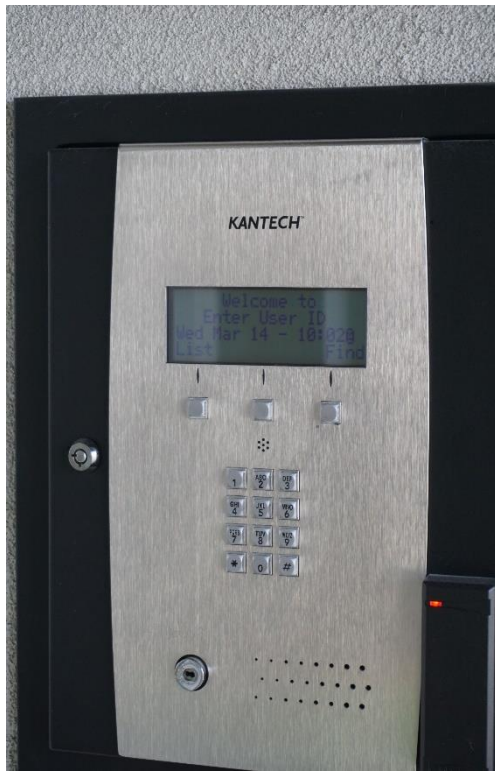
Figure 36 - Intercom system and access card reader.

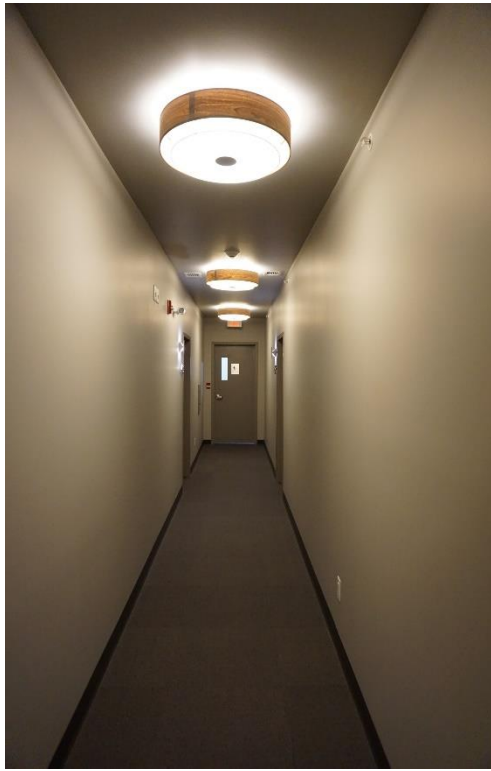
Figure 38 - Typical ceiling mounted pendant fixtures and wall mounted sconces beside the suite numbers.

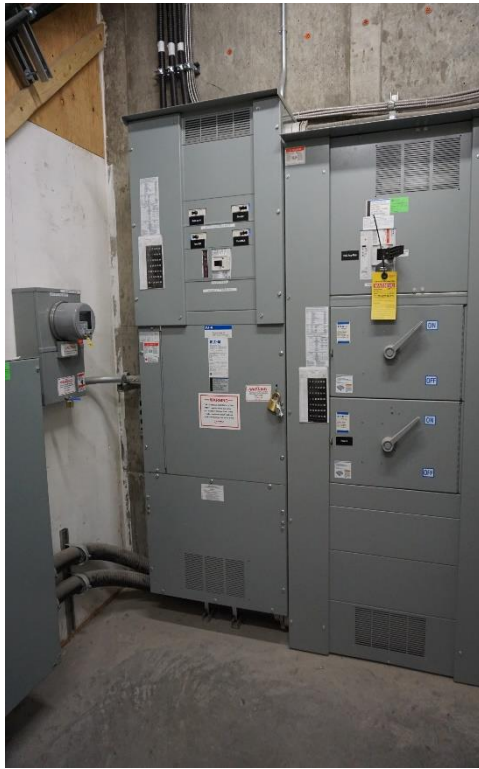
Figure 41 - Main distribution panel with disconnects.

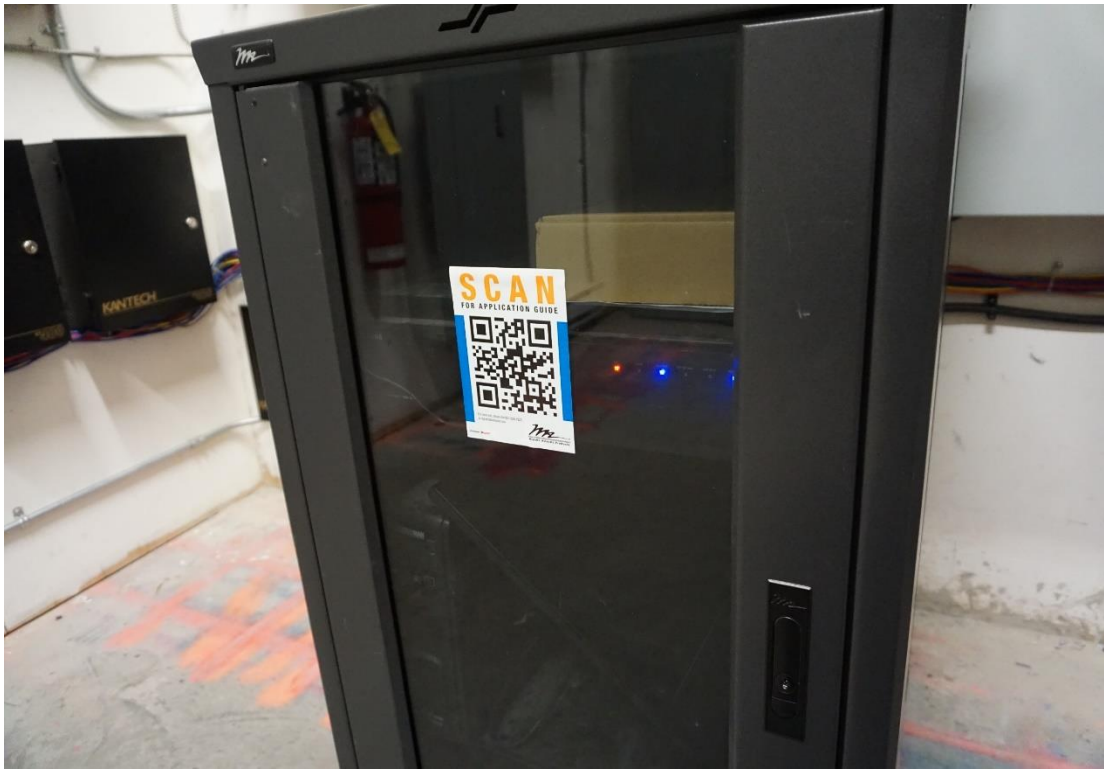
Figure 44 - Security camera system in a locked cabinet.

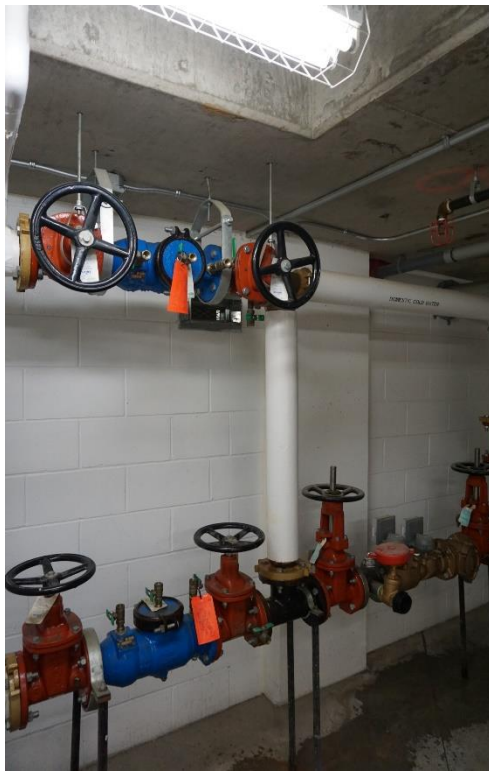
Figure 46 - Two domestic water system backflow prevention devices.

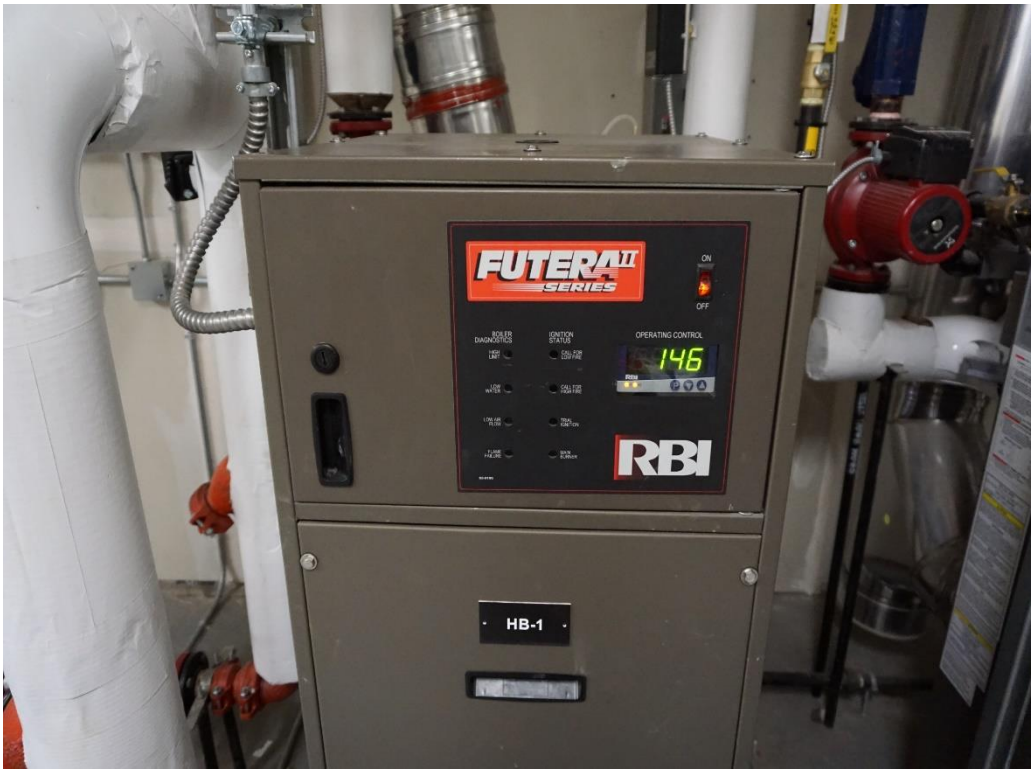
Figure 48 - One of two 1000 MBH heating boilers.

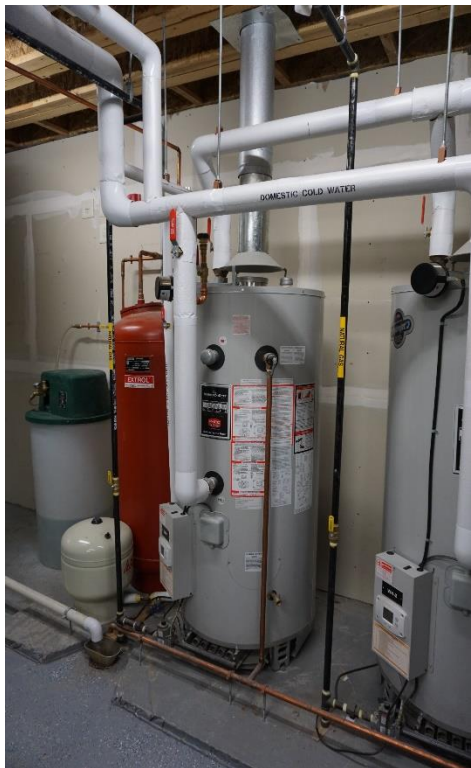
Figure 50 - Chemical mix tank (clear tank with green top) and the domestic hot water expansion tank (small cream-colored tank).
