Reserve Fund Study

ID Inglewood - Condominium Corporation No. 1612056

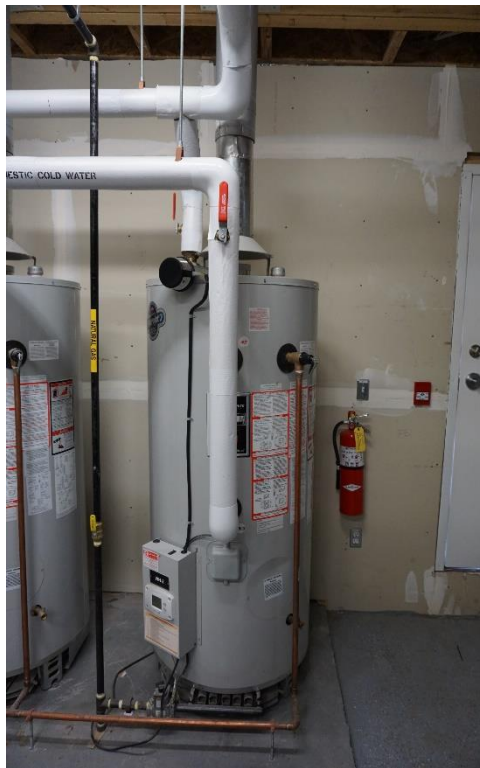
Figure 52 - Bradford White domestic hot water tanks.

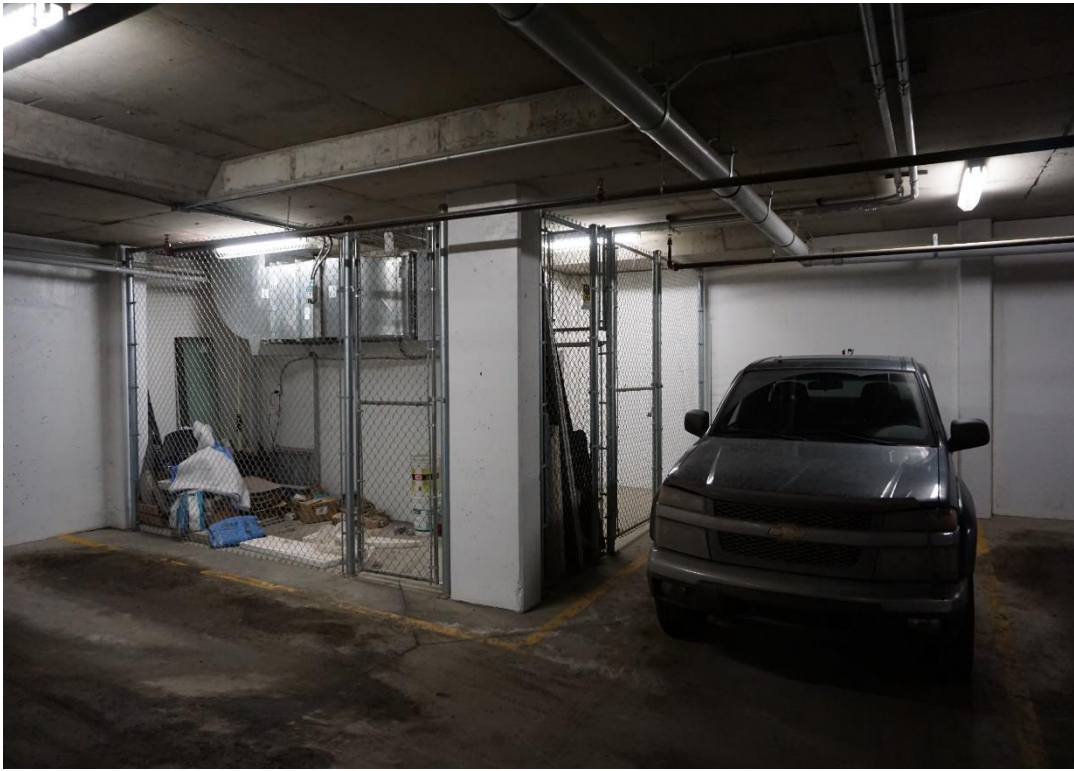
Figure 54 - Parkade exhaust fan.

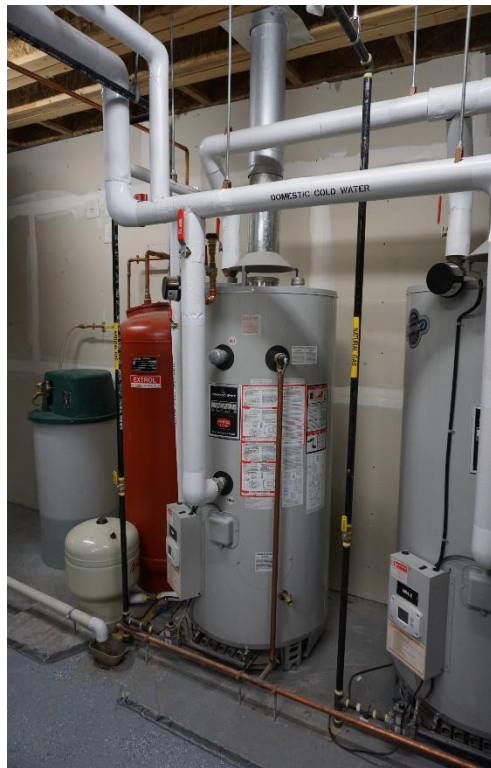
Figure 58 - Expansion tank for the residential boilers (red tank).

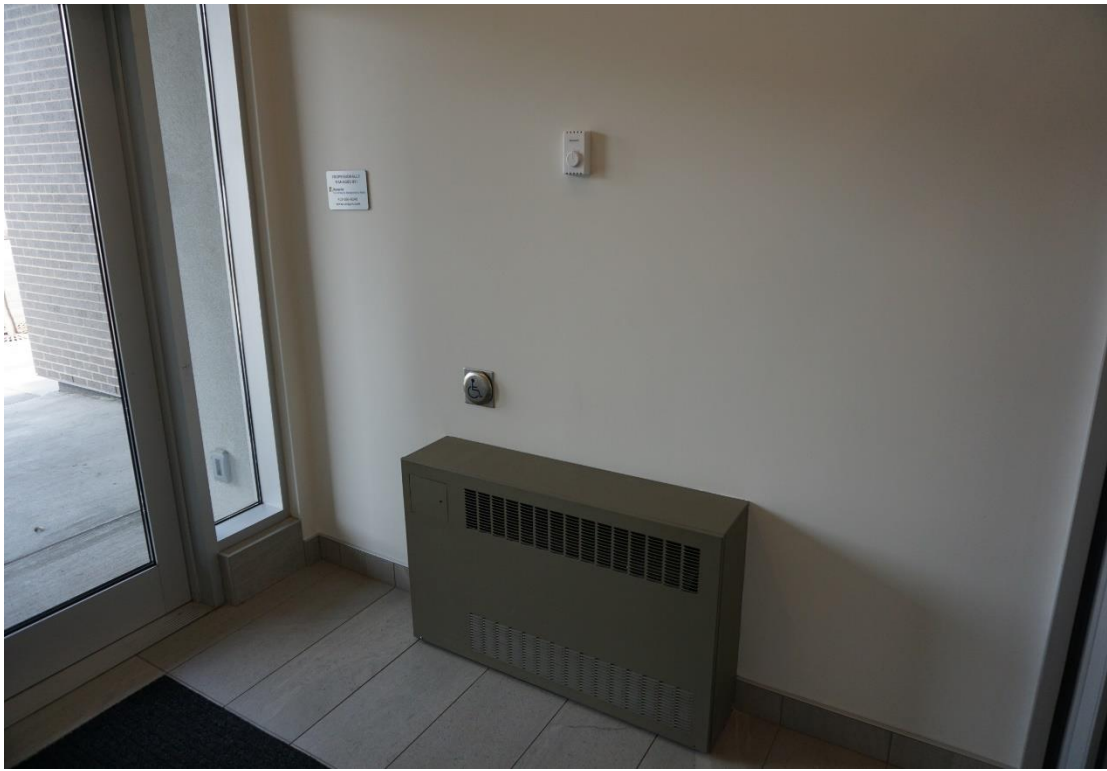
Figure 60 - Force flow heater in the front entrance vestibule.

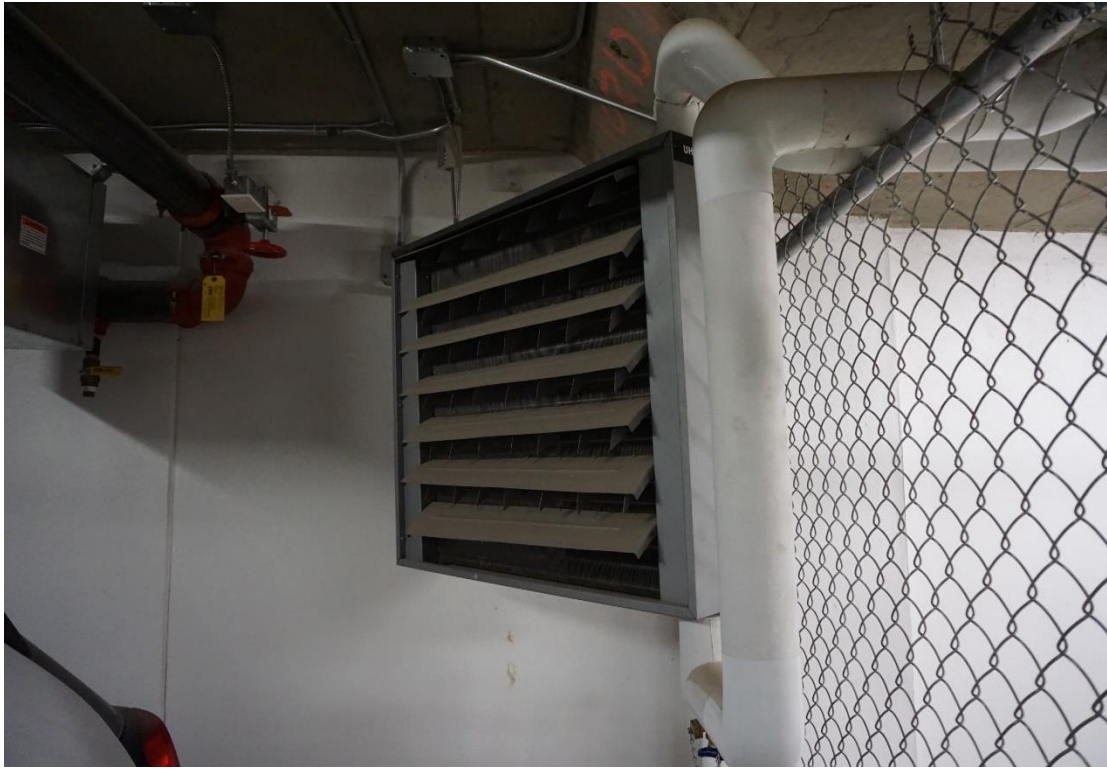
Figure 61 - Hydronic unit heater in the parkade.

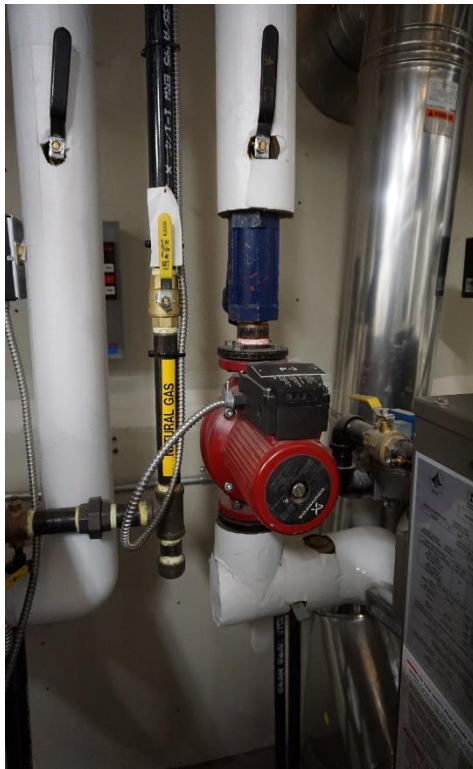
Figure 62 - Boiler recirculating pump (P-3).

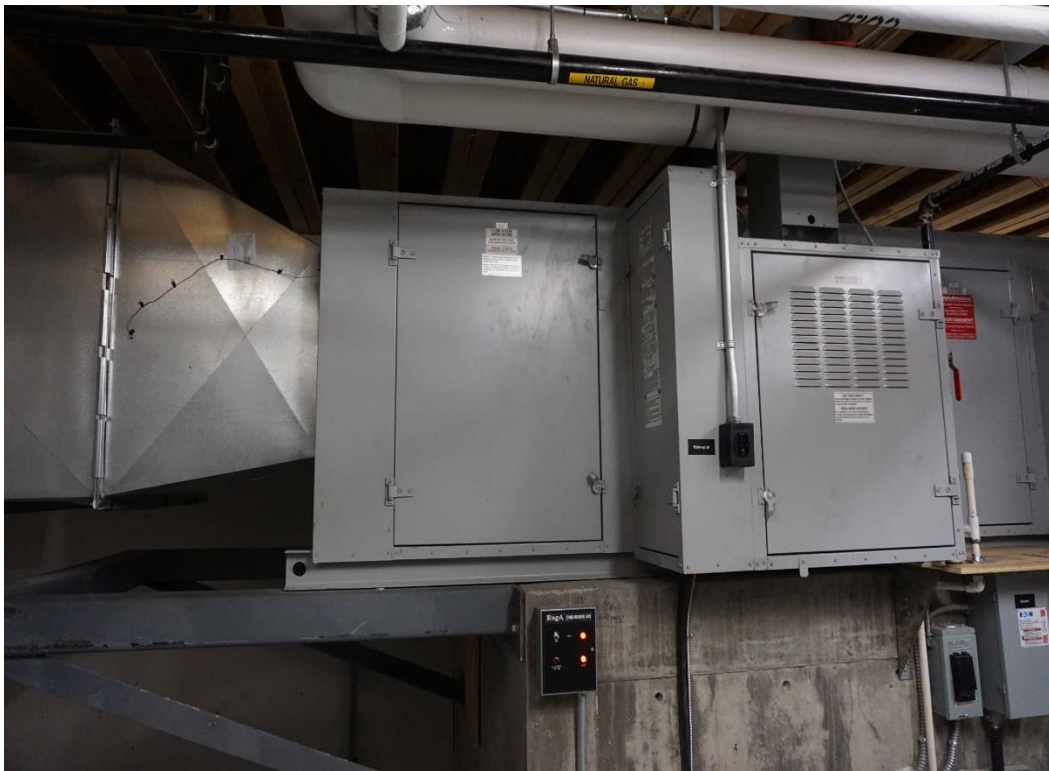
Figure 64 - Engineered Air hallway make-up air unit (MUA).

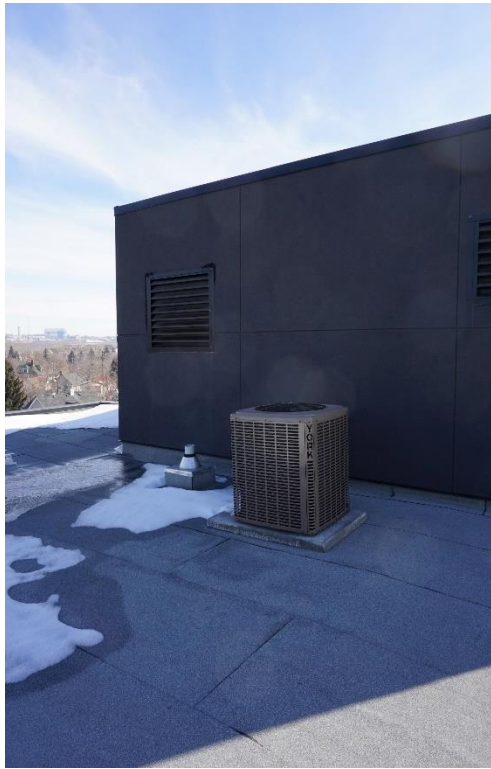
Figure 65 - Hallway MUA condensing unit

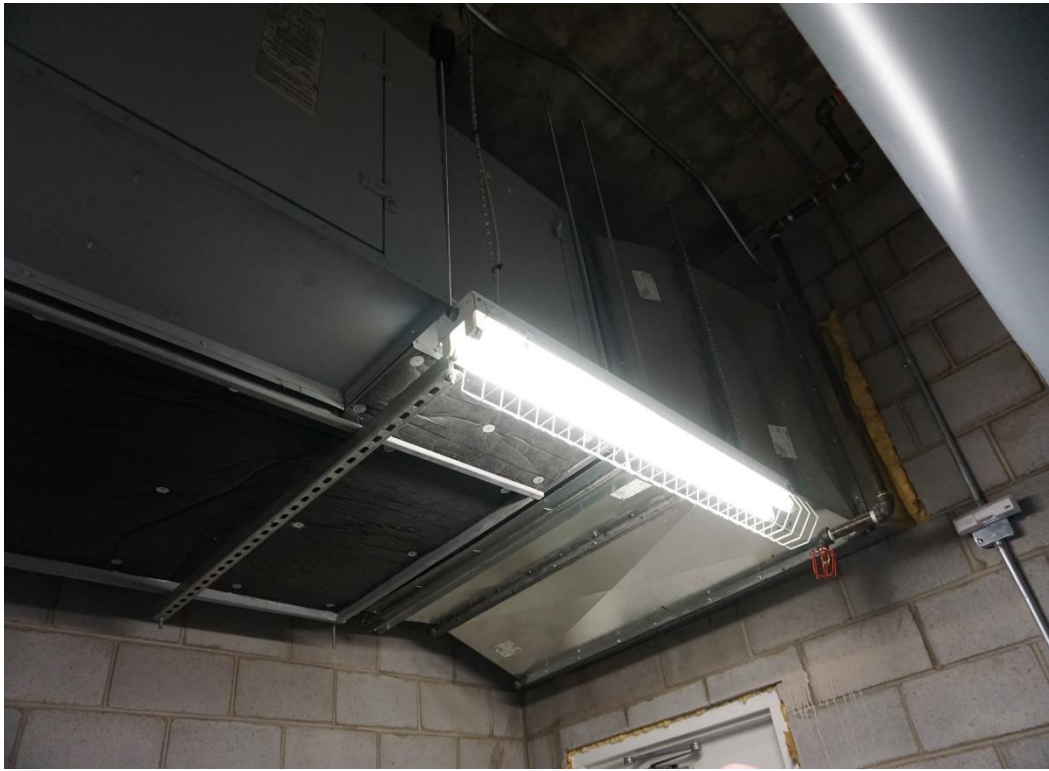
Figure 66 - Parkade make-up air unit (MUA).

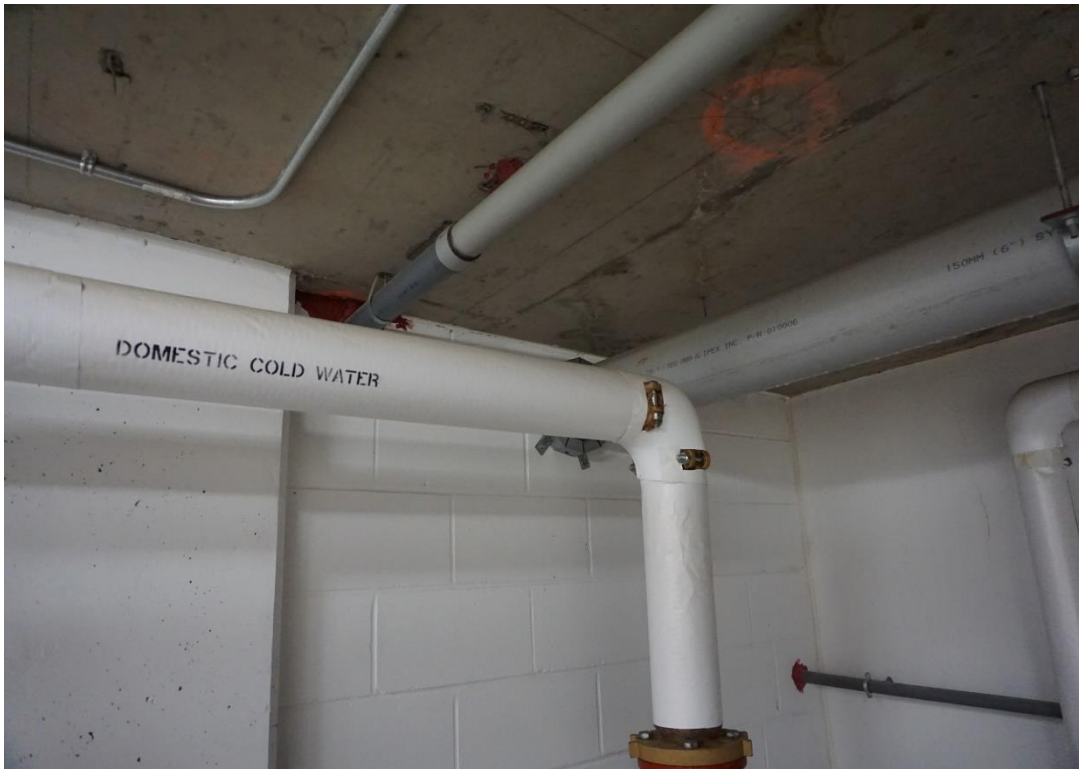
Figure 67 - Insulated domestic cold-water lines.

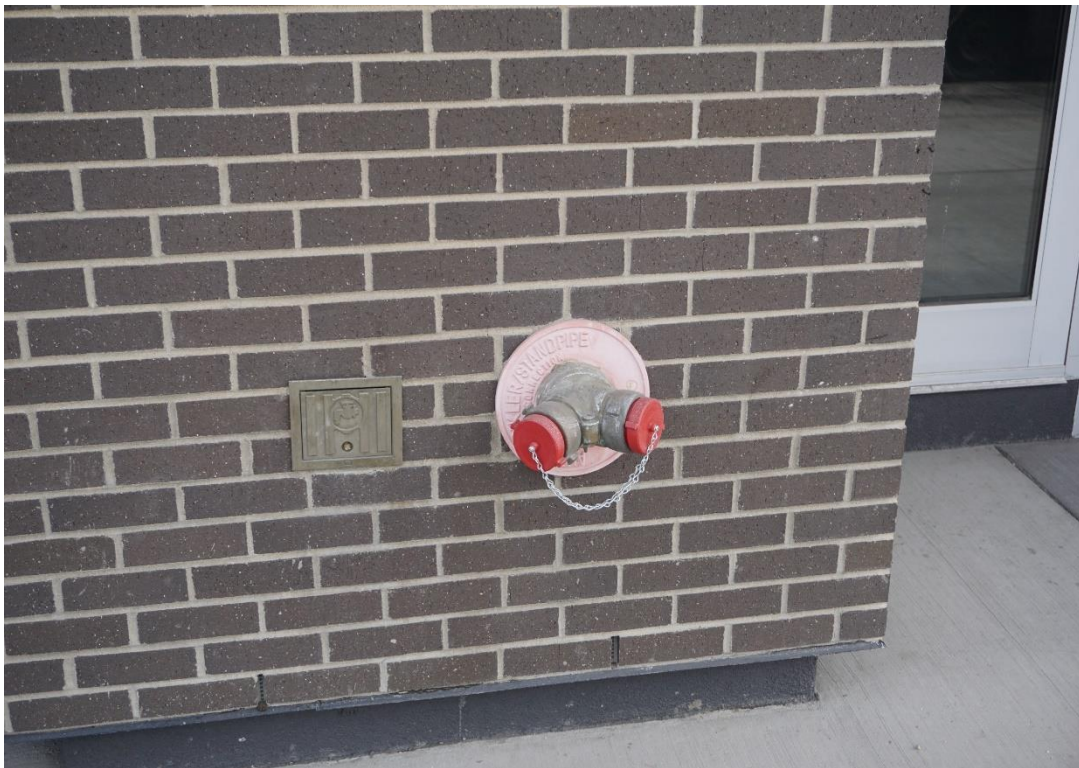
Figure 68 - Frost-free hose bibb.

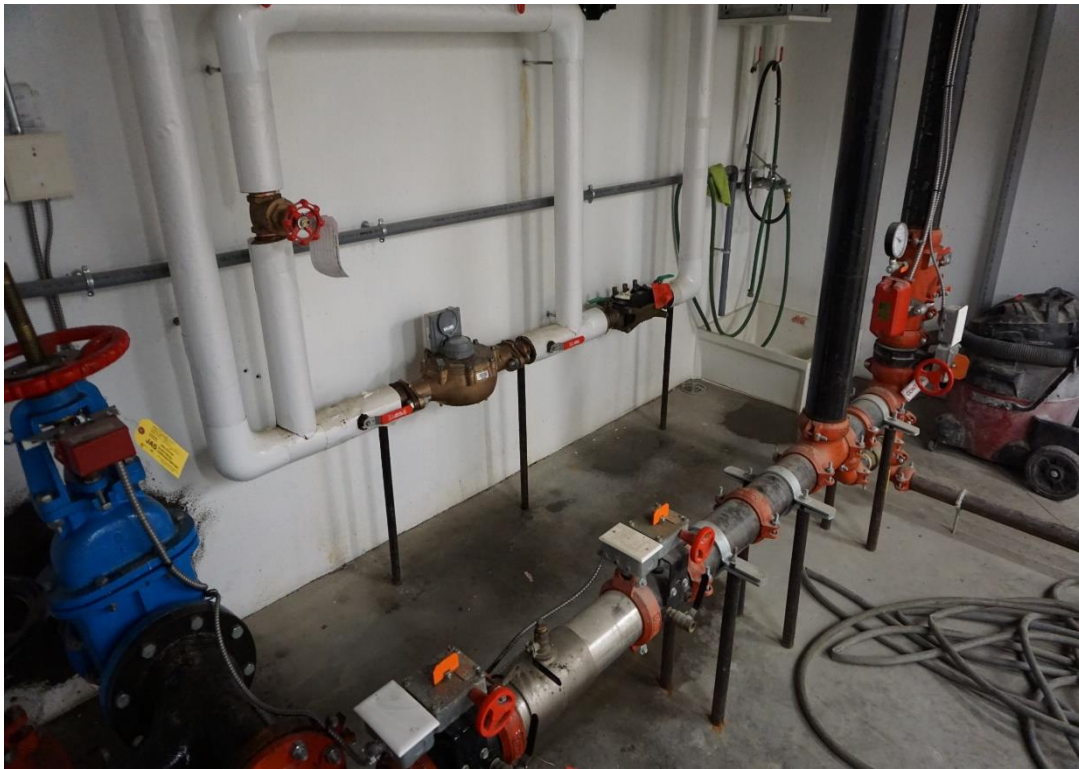
Figure 69 - Service sink and faucet.

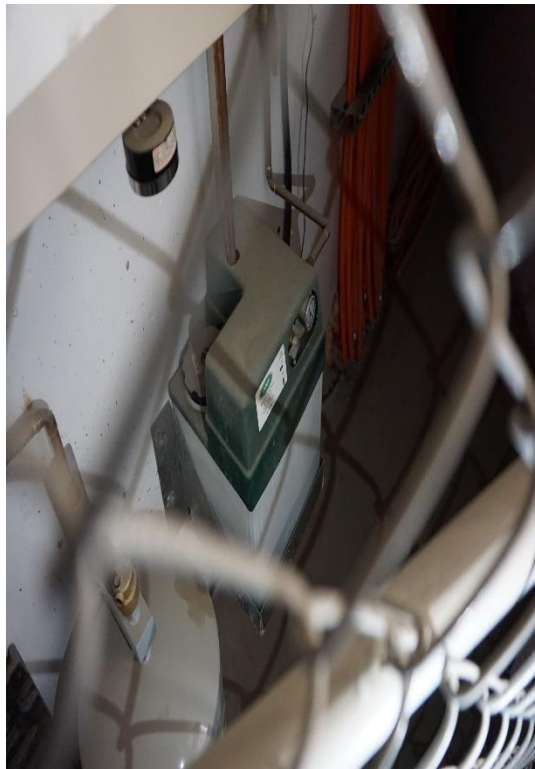
Figure 71 - Snow melt system controller.

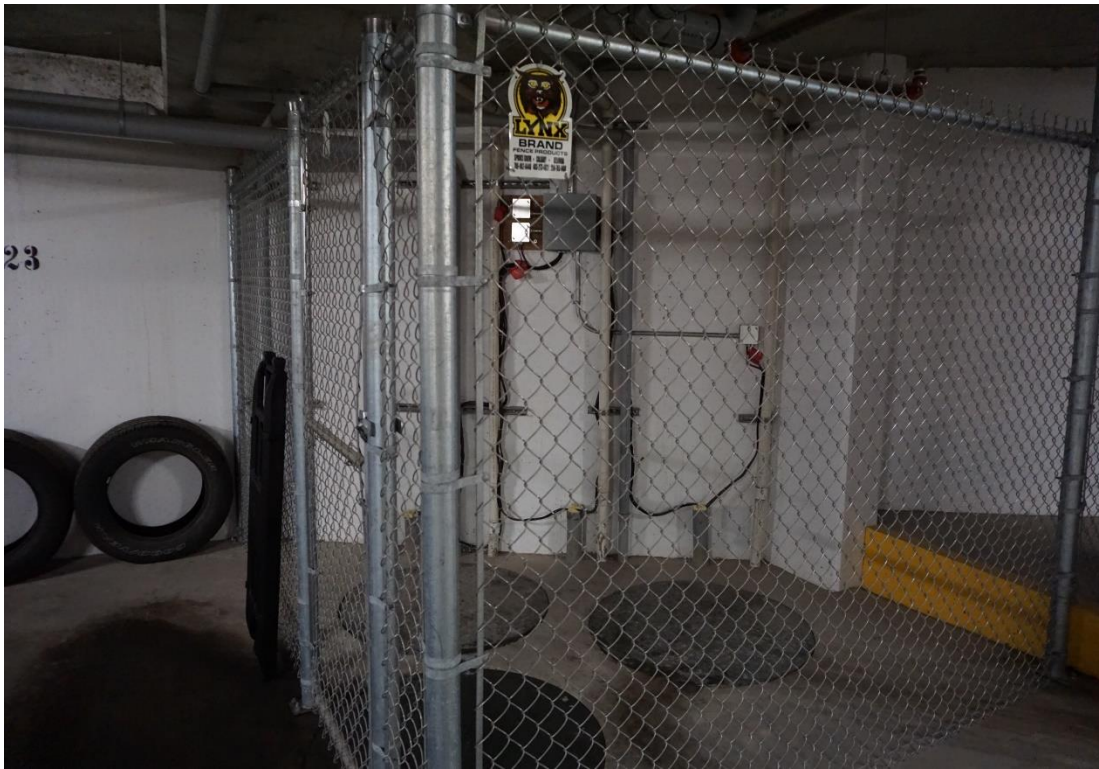
Figure 72 - Sump cage with three basin covers. The sump pumps are located at the bottom of the basins.

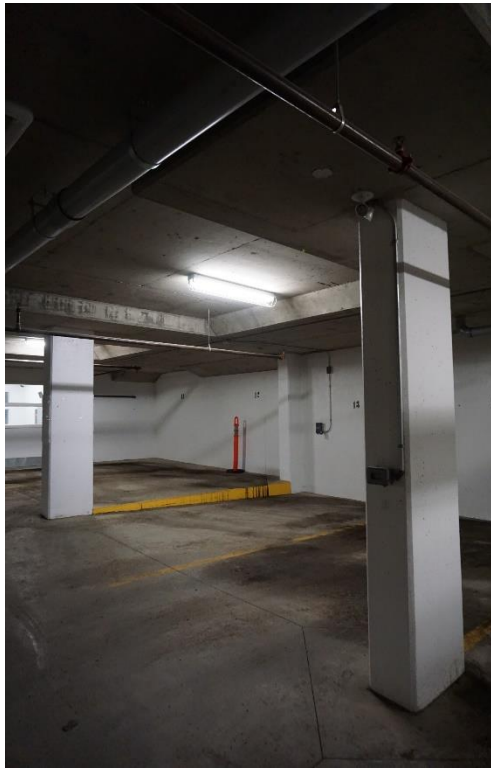
Figure 74 - CO/NO2 detector on the wall of stall 13.

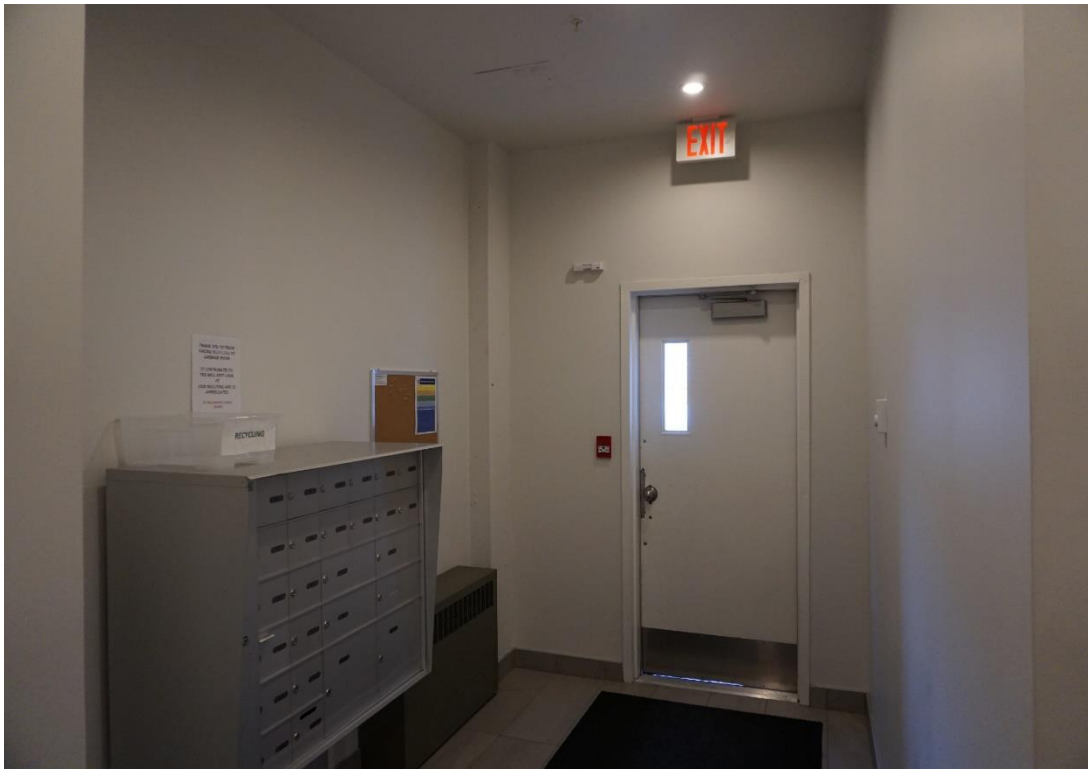
Figure 75 - Exit sign and pull station.

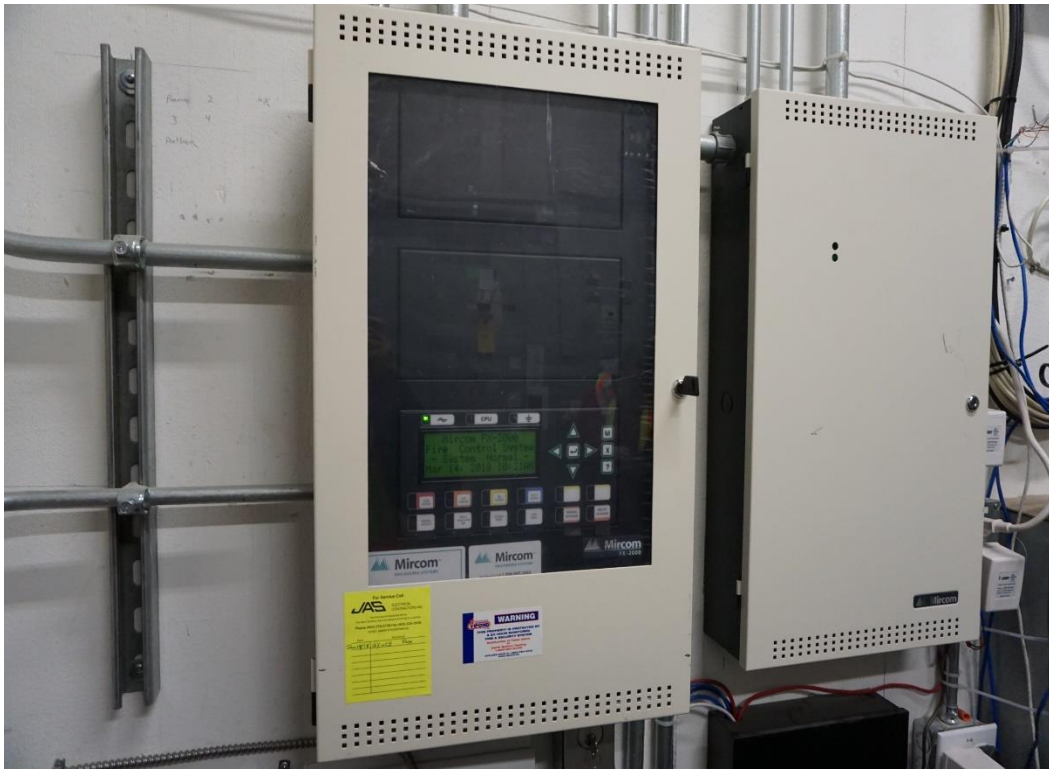
Figure 78 - Fire alarm panel.

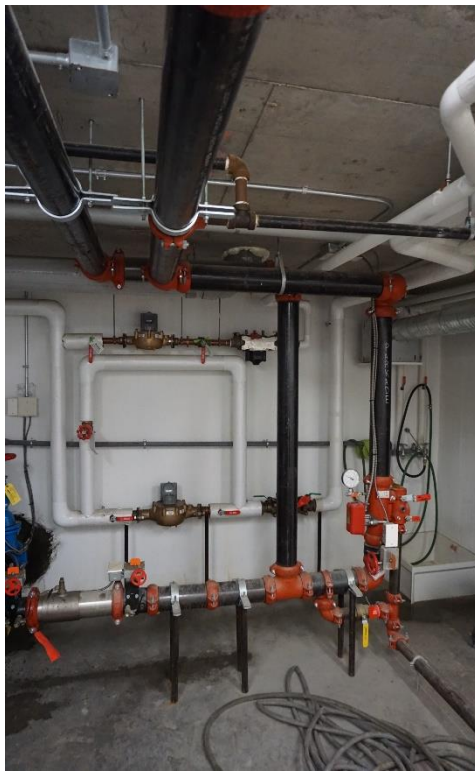
Figure 81 - Fire sprinkler tree.

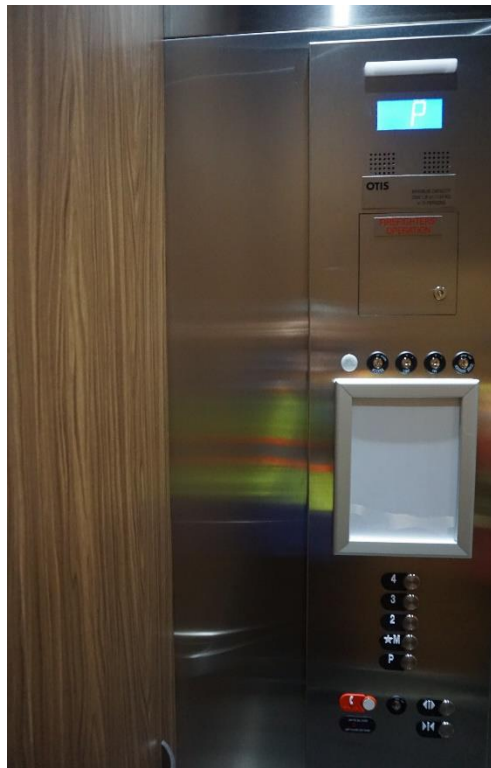
Figure 84 - Partial view of the cab interior.

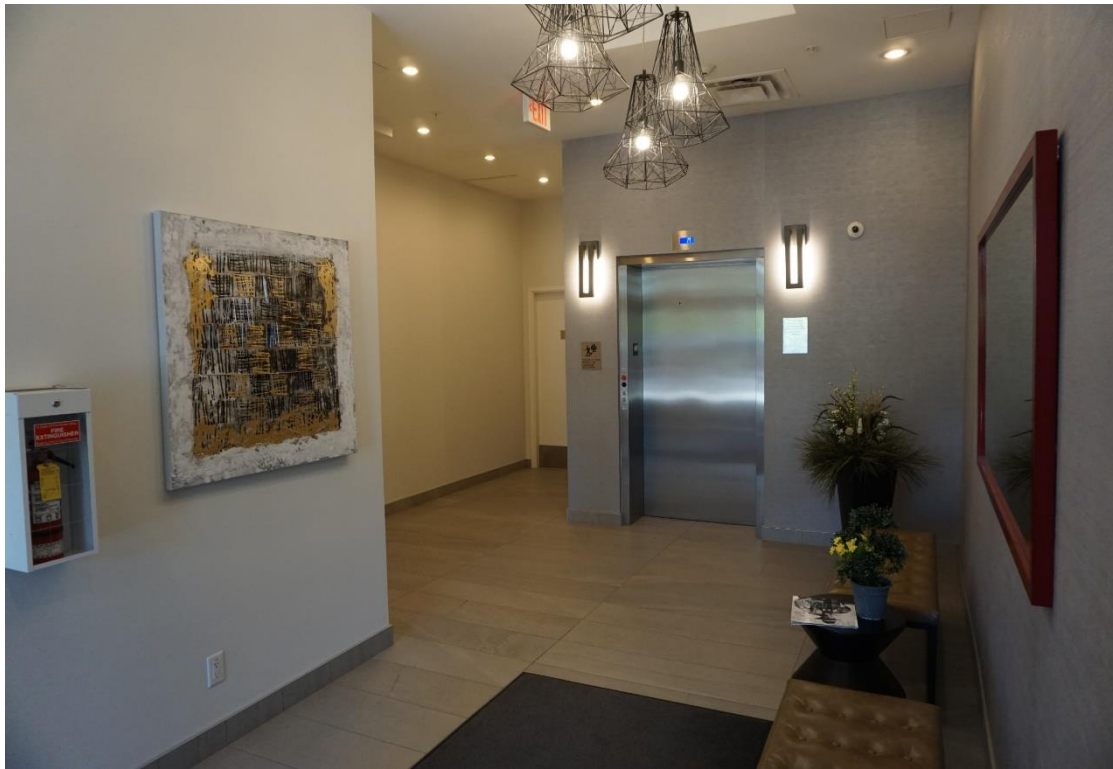
Figure 86 - Elevator in the main lobby.

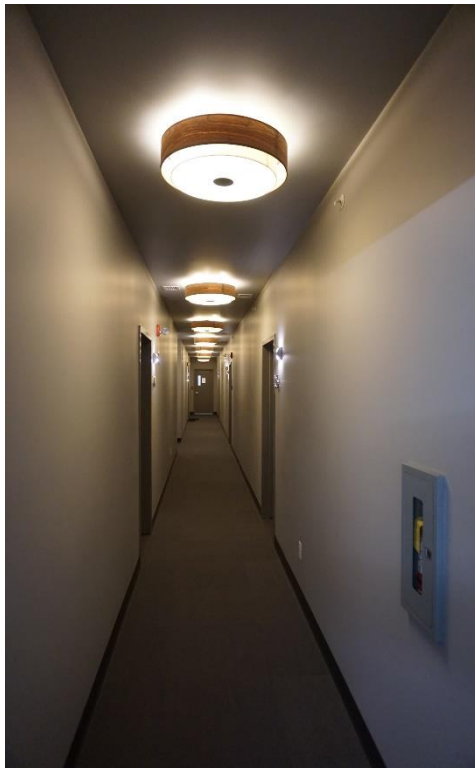
Figure 87 - Hallway carpet tile and rubber baseboard.

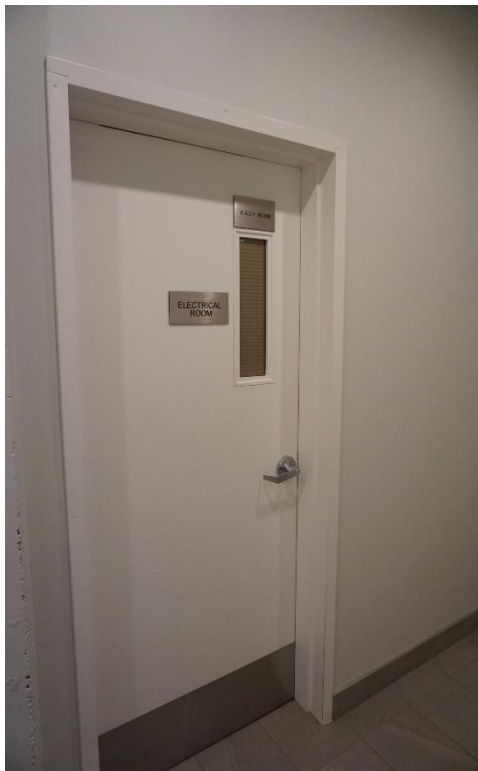
Figure 89 - Example of a common area hollow core metal door with a vision lite.

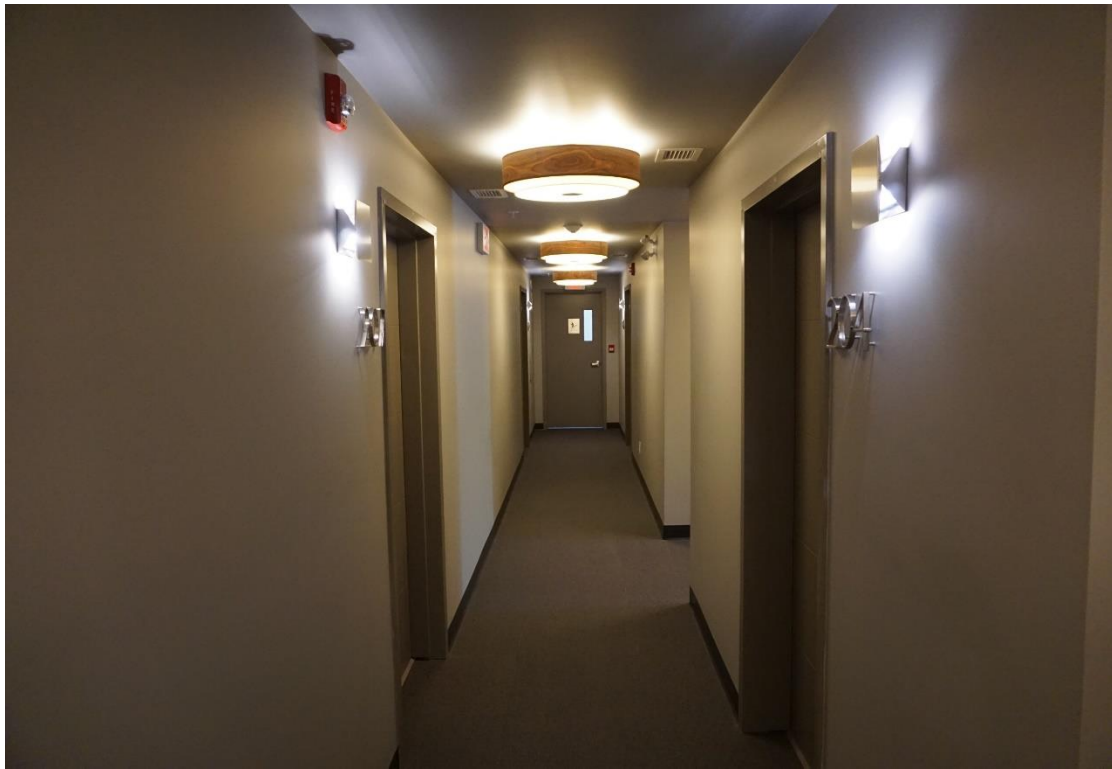
Figure 91 - Drywall ceilings and walls in the hallway.

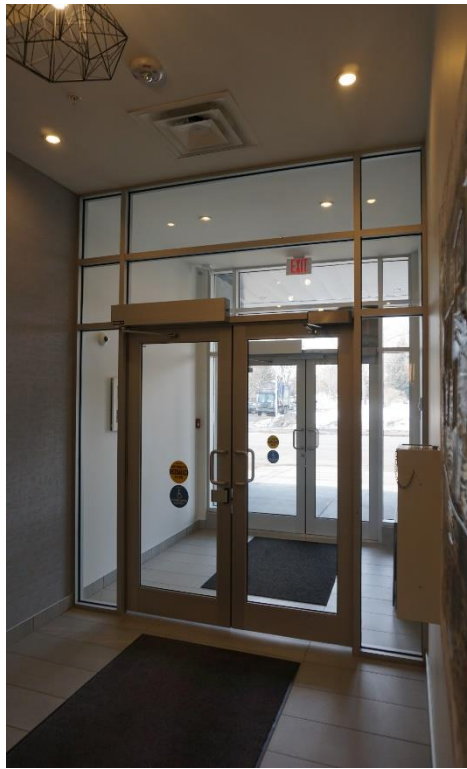
Figure 93 - Ceramic tile and base in the front entrance vestibule and lobby.

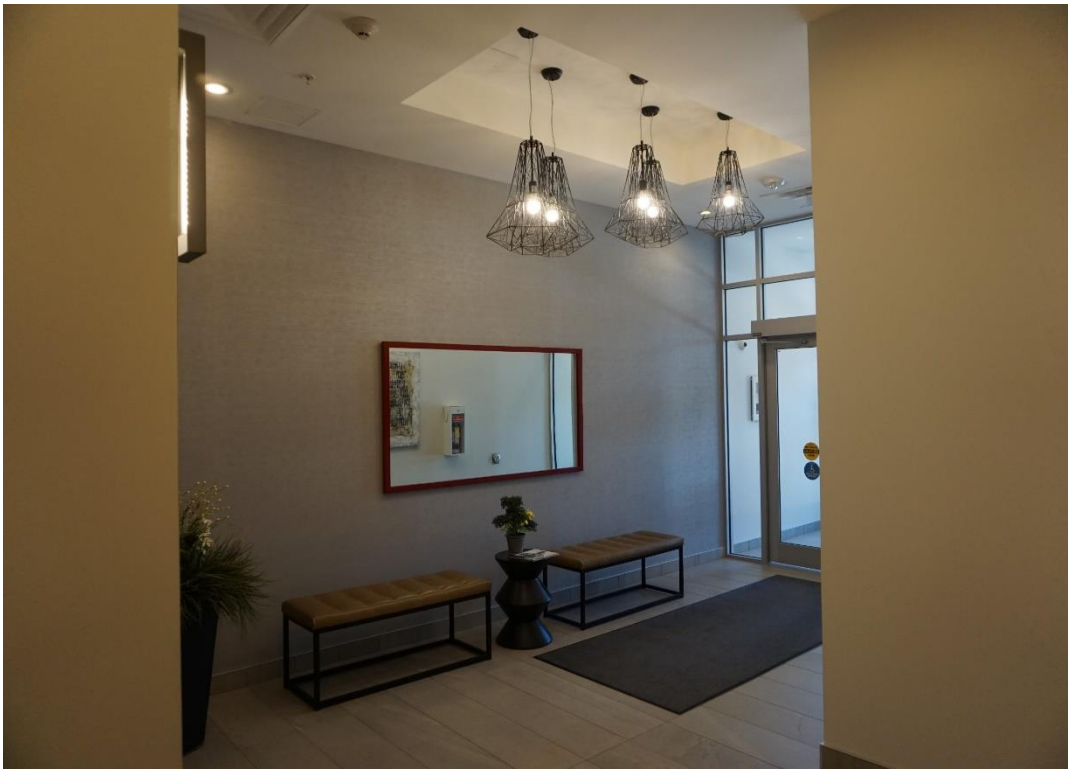
Figure 94 - Lobby furniture and decoration.

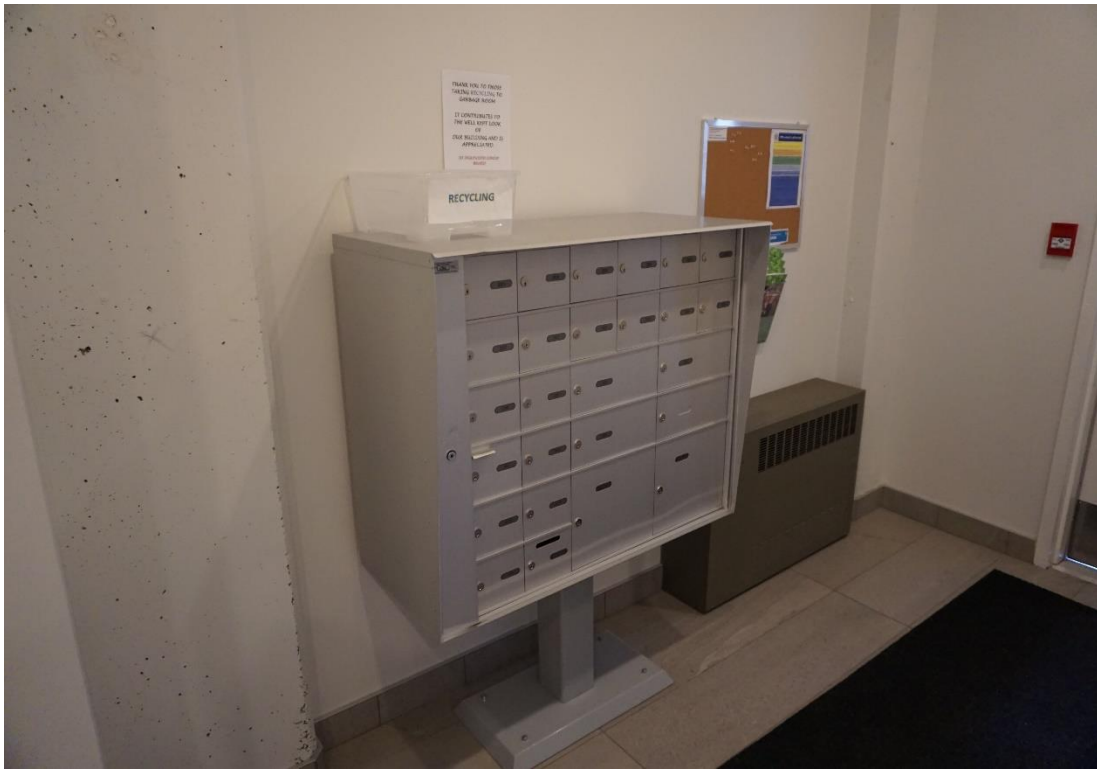
Figure 95 - Front load mailbox.

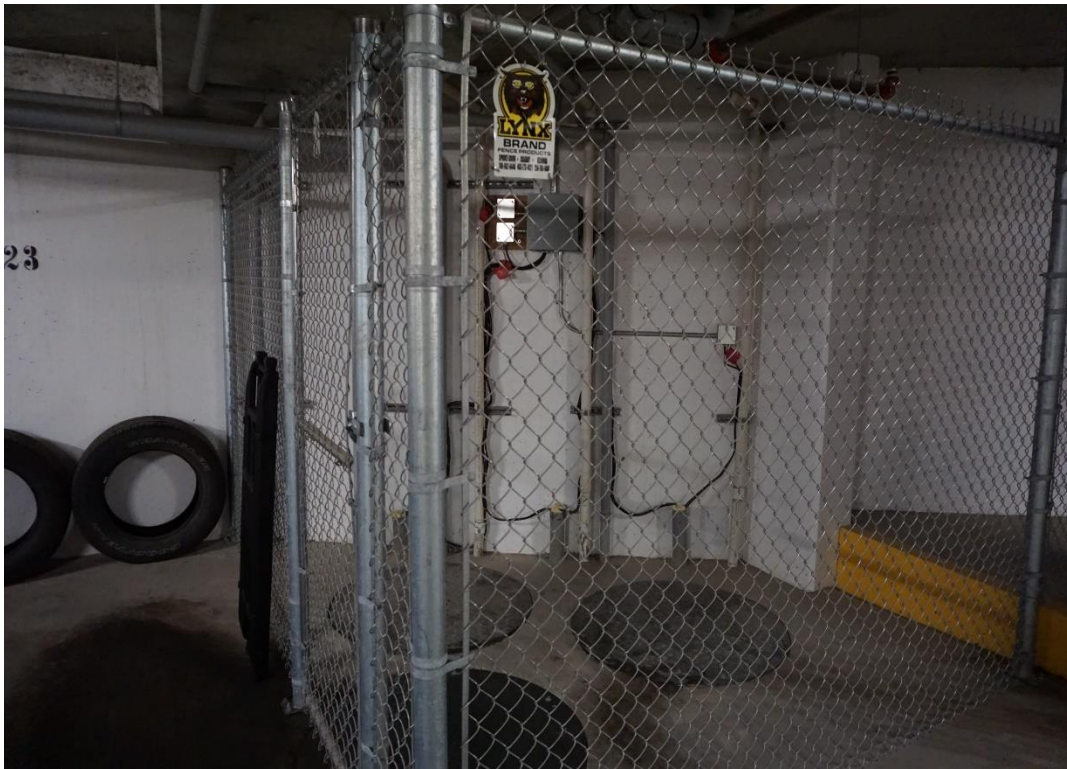
Figure 96 - Chain-link service area in the parkade.

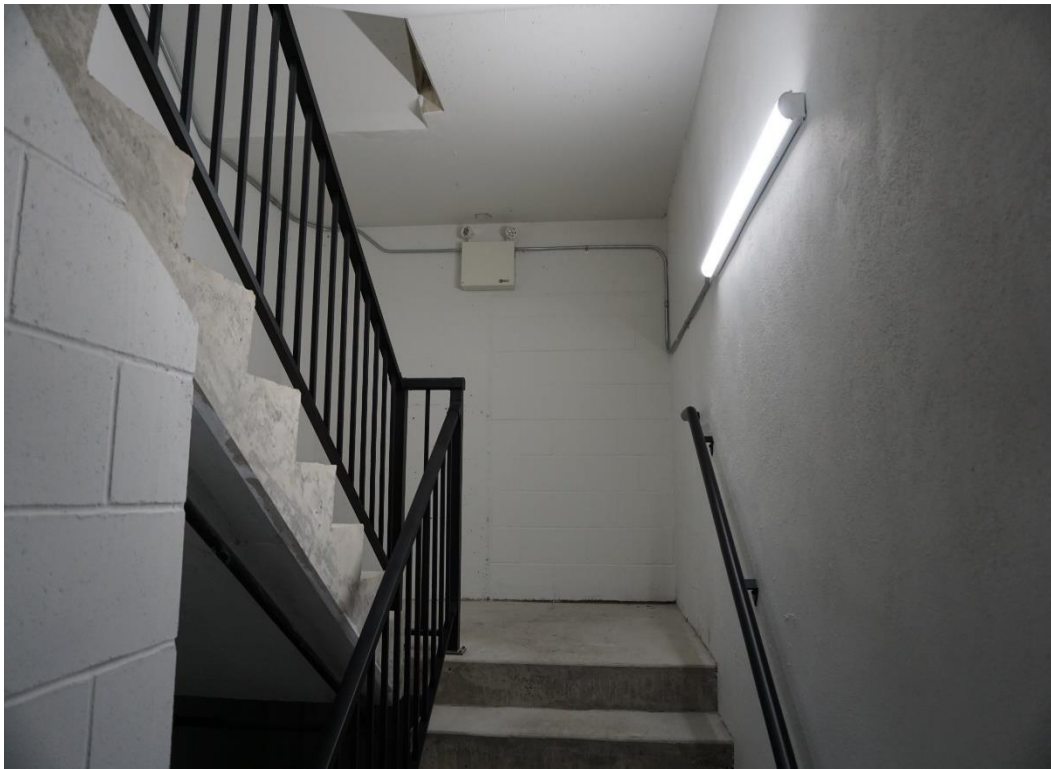
Figure 98 - Painted walls and ceiling in the stairwell.

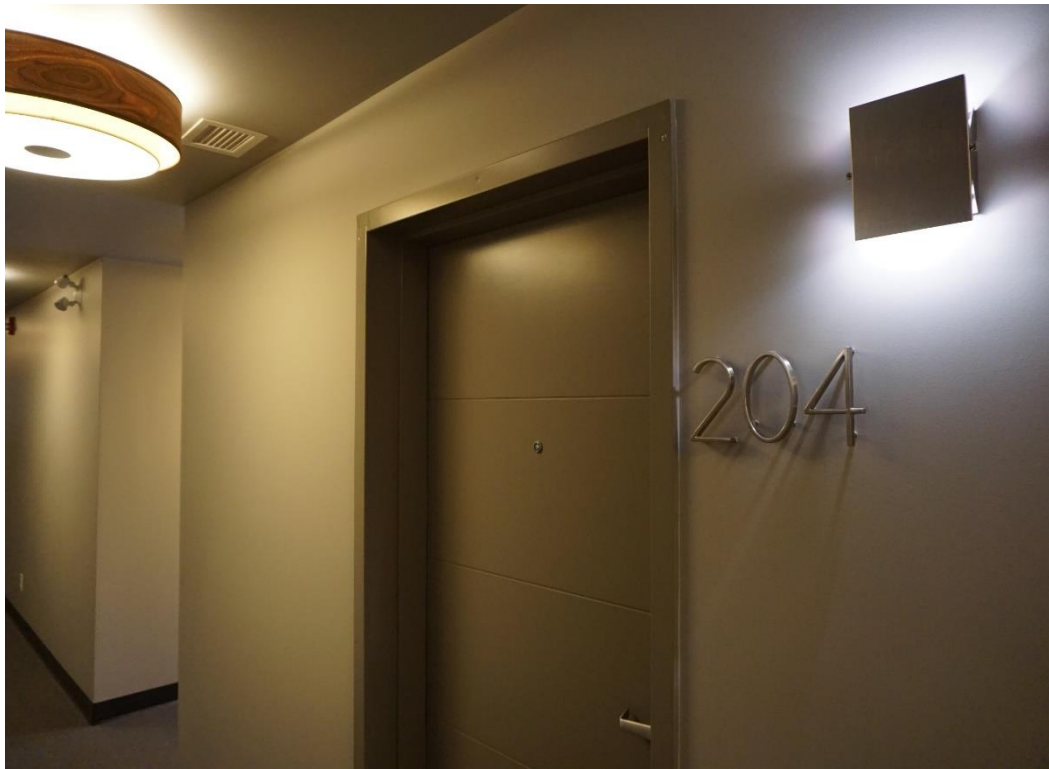
Figure 99 - Painted surfaces including wall, ceiling, door & frame.

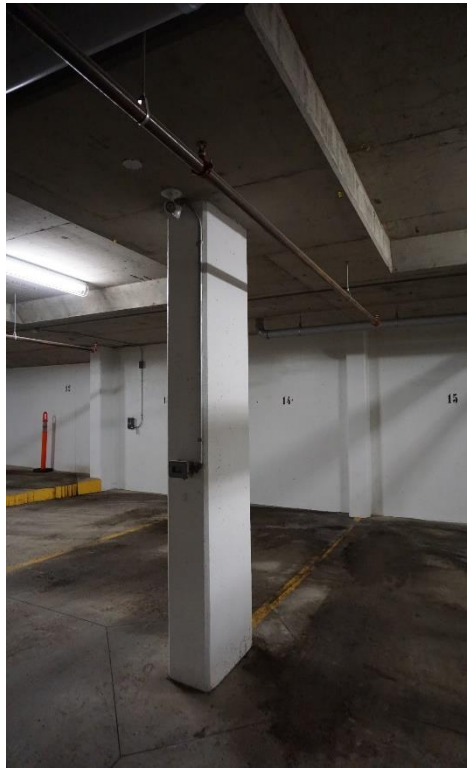
Figure 100 - Painted walls and columns in the parkade.

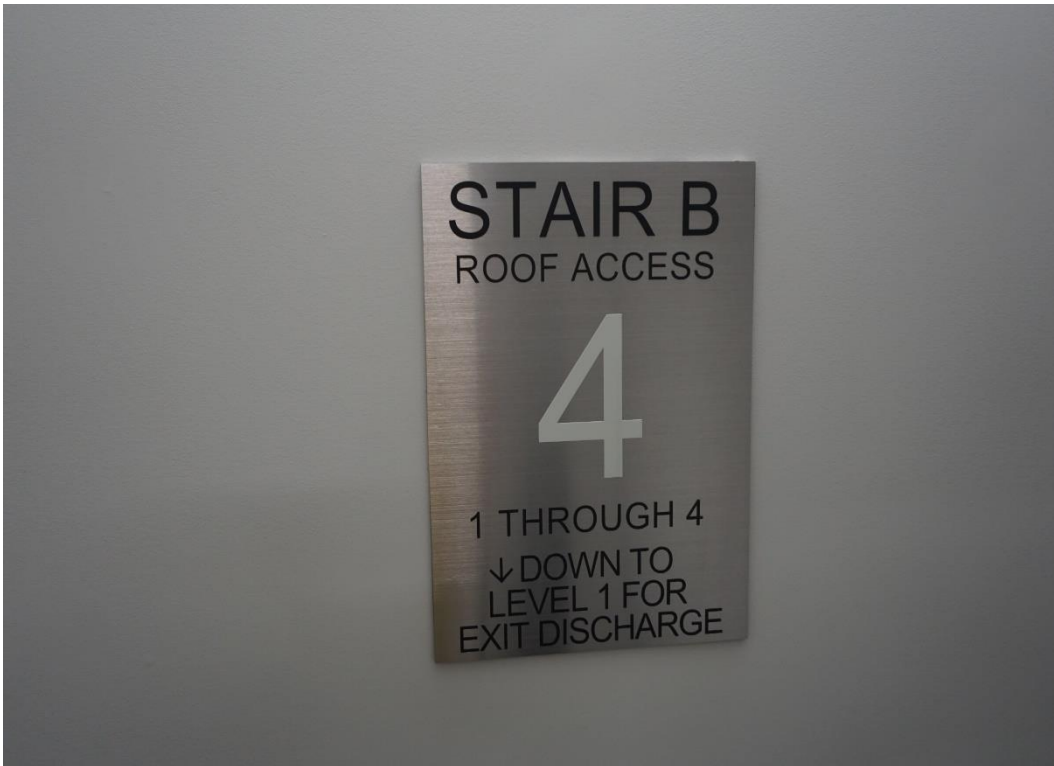
Figure 101 - Example of the informational signage.

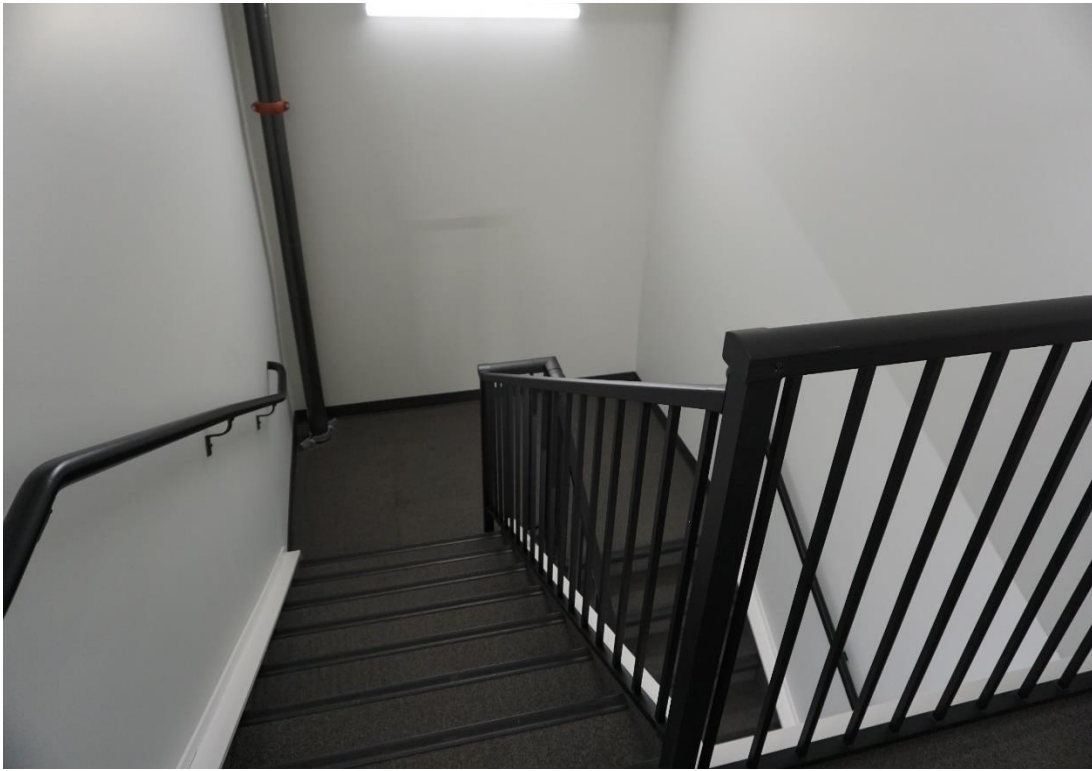
Figure 103 - Stairwell railing and bannister.

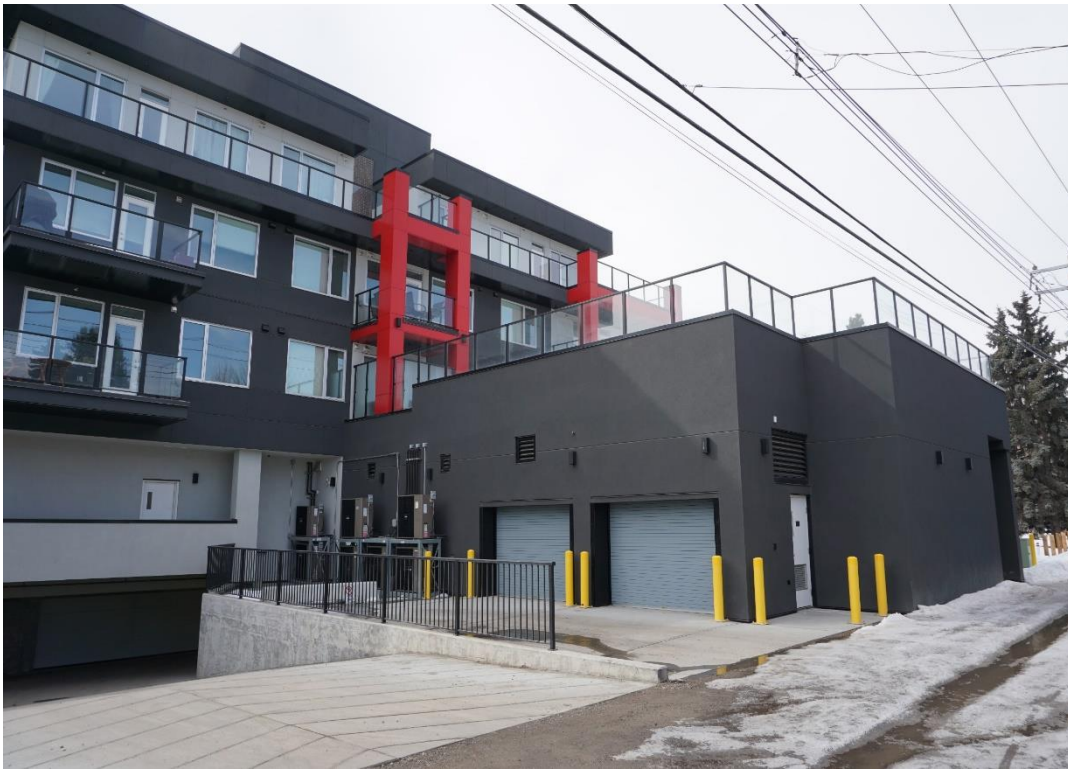
Figure 104 - Concrete elements including the parkade ramp, loading area and jersey barrier. Also shows the retaining wall.

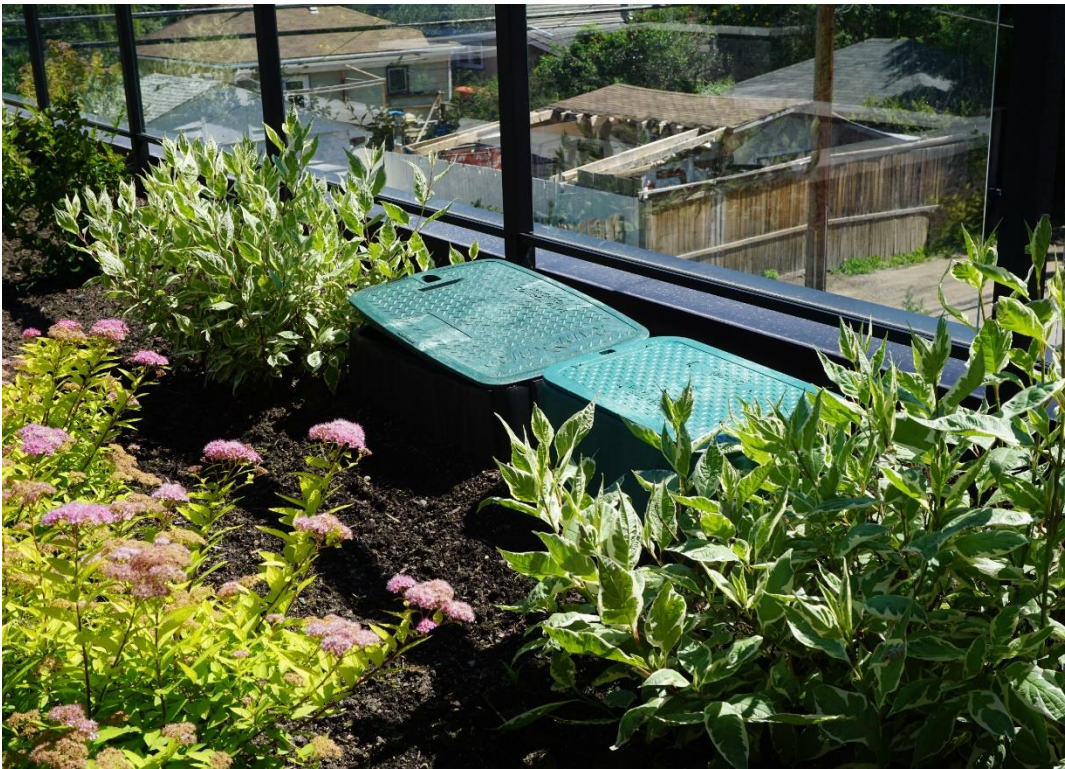
Figure 106 - Irrigation valve boxes.
