Reserve Fund Study

ID Inglewood - Condominium Corporation No. 1612056

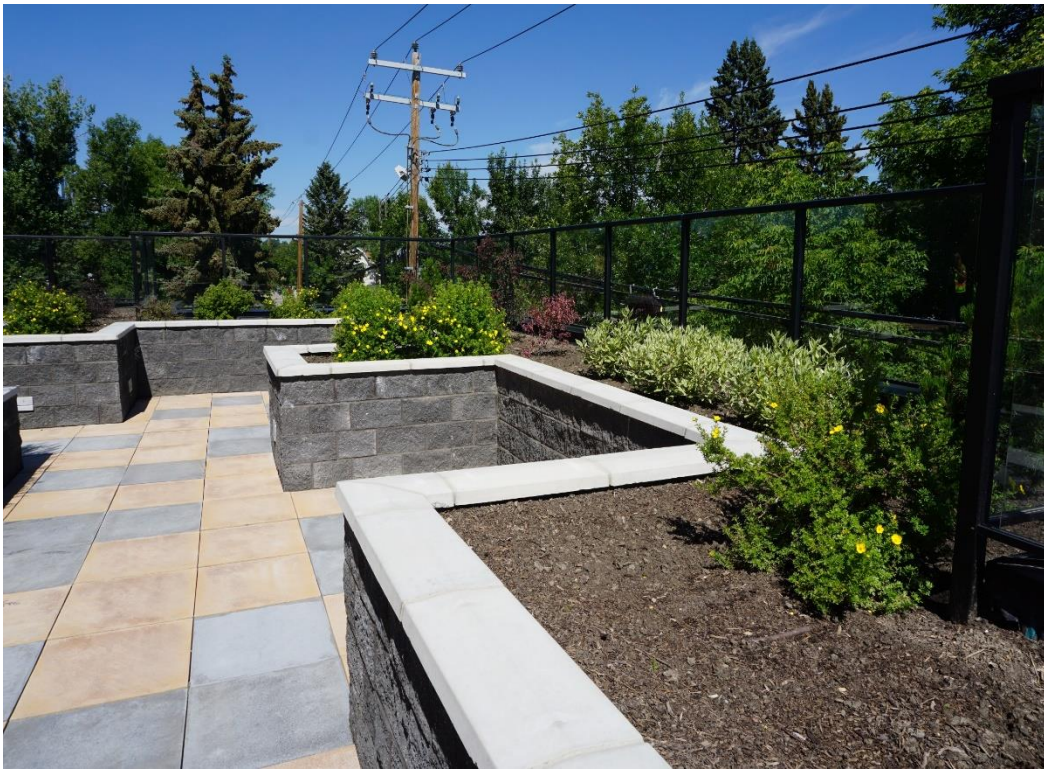
Figure 108 - Shrubs in the raised terrace planters.

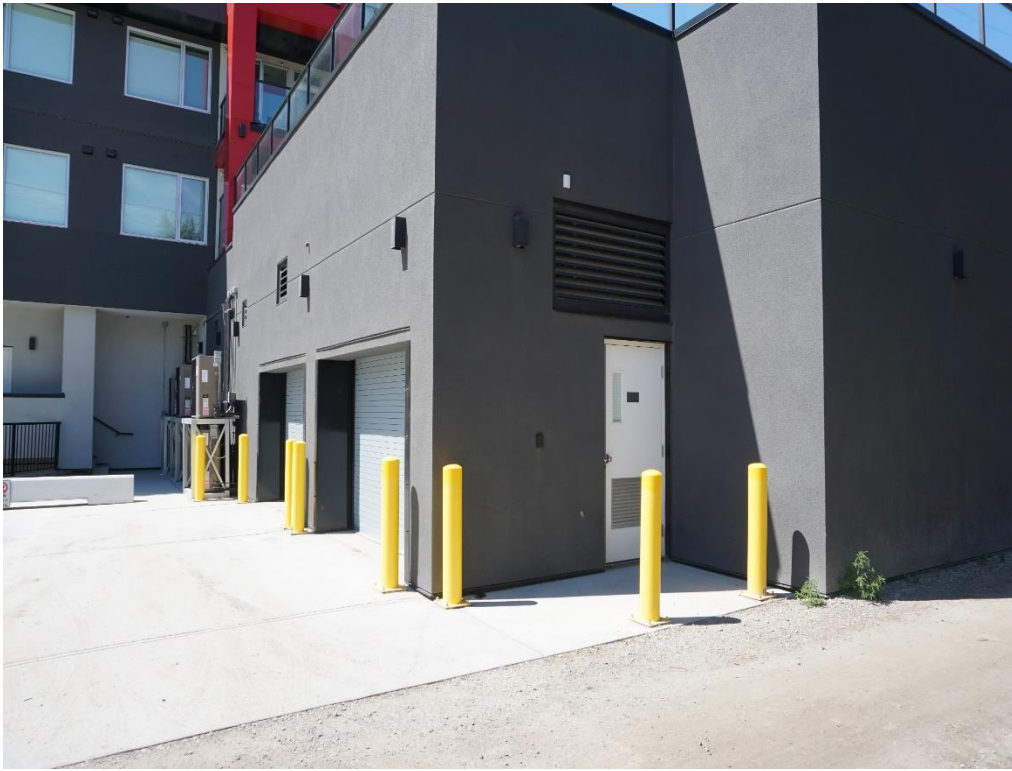
Figure 110 - Metal bollards at the rear of the building.

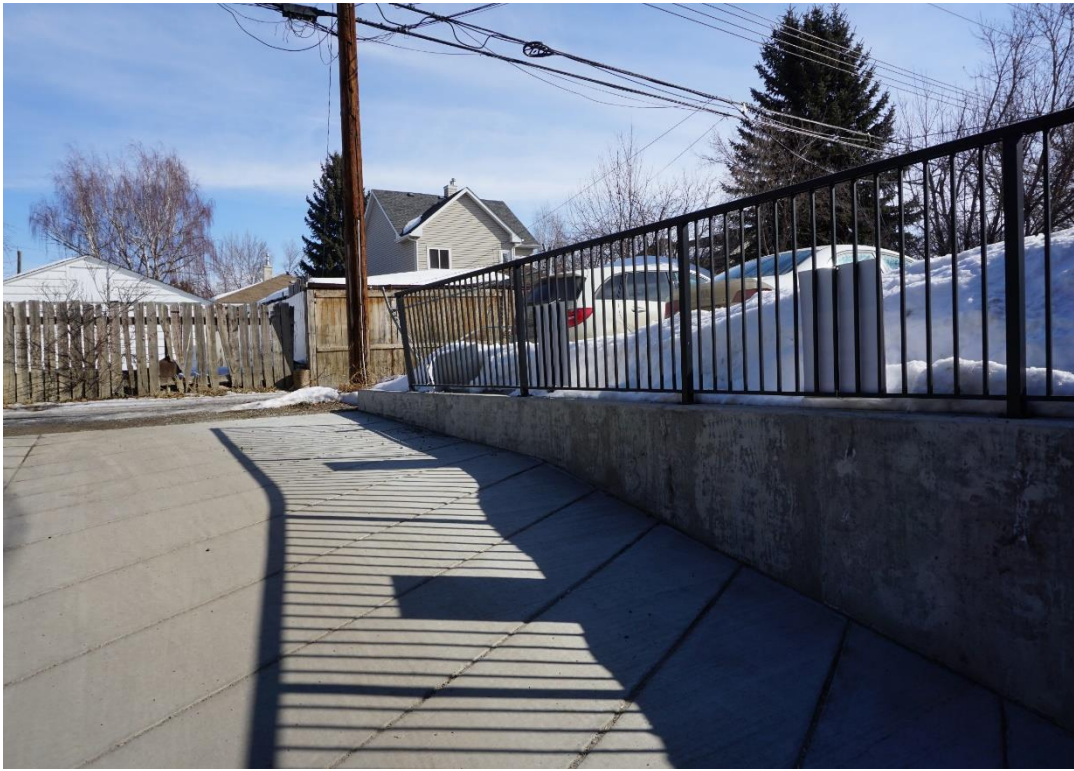
Figure 111 - Guard rail on the parkade ramp.

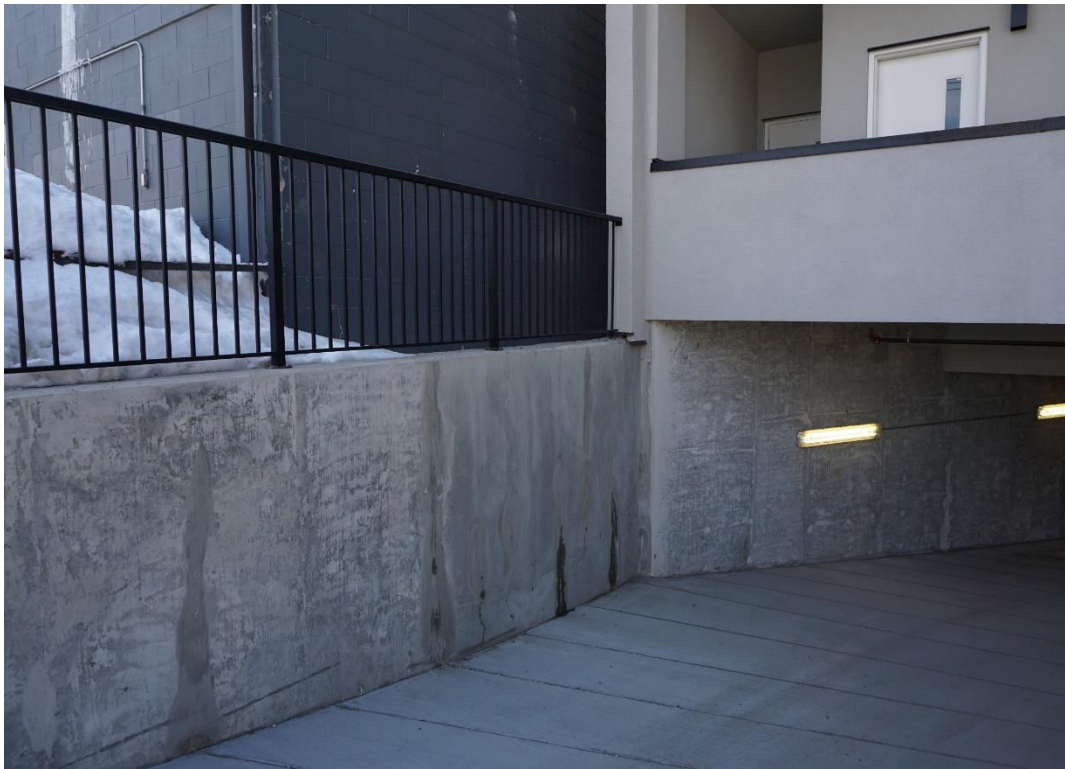
Figure 112 - Concrete retaining wall on the east side of the parkade entrance ramp. Shows some vertical cracking and active leaking.

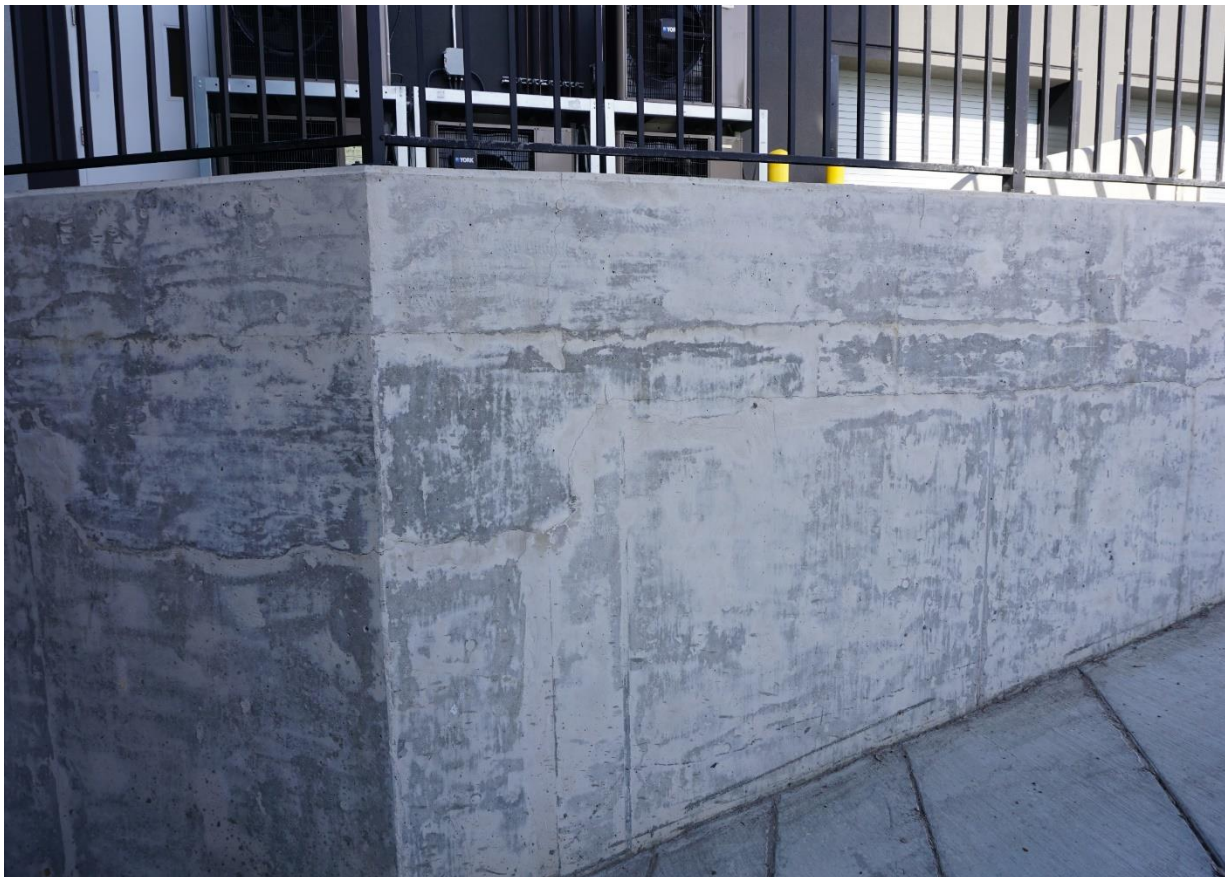
Figure 113 - Concrete retaining wall on the west side of the parkade entrance ramp. Shows long horizontal crack.

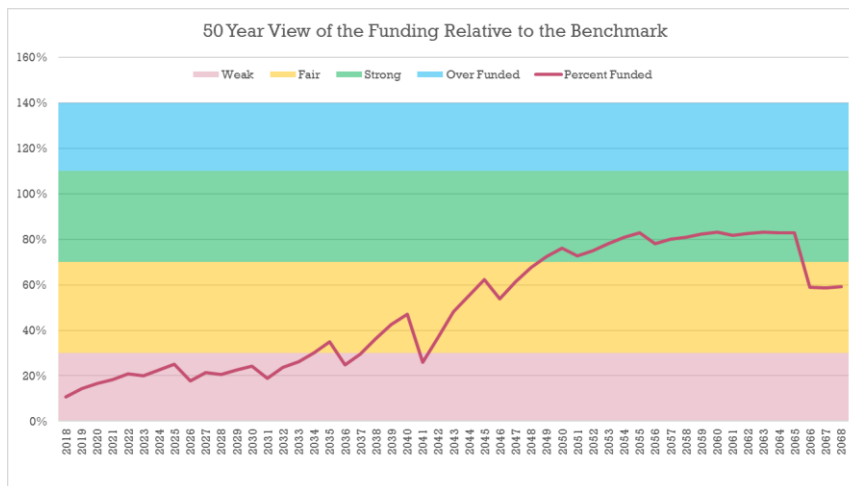
Figure 124 - Critical Year funding model strength visual.
